## General Information

| Make | Toyota | Model | Vios |
| Registration No. | CCD2479 | Chassis No. | PA1B18F32R4246287 |

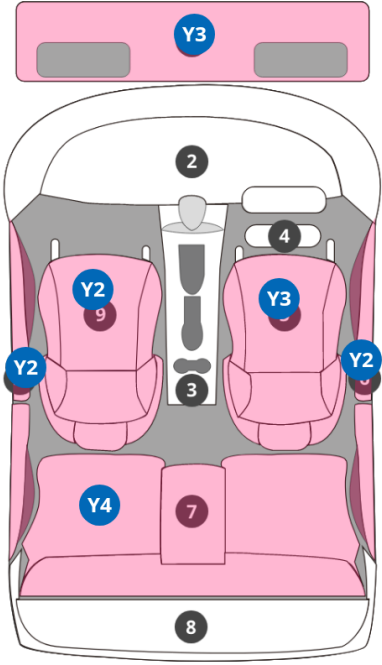
| Interior Evaluation : <span style="color: red;">C</span> | Exterior Evaluation : <span style="color: red;">E</span> |
| <p><b>Remarks</b></p> <p>Ceiling - Grime - Medium / (R) Front Trim - Grime - Small / (R) Front Seat - Grime - Medium / Rear Seat - Grime - Large / (L) Front Trim - Grime - Small / (L) Front Seat - Grime - Small</p> | <p><b>Remarks</b></p> <p>(R) Front Door - Repair Traces - Yes / (R) Step - Repair Traces - Yes / (R) Front Fender - Repair Traces - Yes / (L) Front Fender - Repair Traces - Yes / (L) Rear Door - Repair Traces - Yes / (L) Rear Fender - Repair Traces - Yes / Trunk Hood, Rear Gate - Repair Traces - Yes / (R) Rear Fender - Repair Traces - Yes / (R) Rear Door - Repair Traces - Yes / Roof - Repair Traces - Yes / (R) Front Door, Molding - Repair mark - Yes / (R) Front Fender, Molding - Repair mark - Yes / (R) Front Fender, Molding - Dent - Small / (R) Mirror - Scratch - Small / (R) Front Door, Molding - Scratch - Minimal / (R) Rear Door, Molding - Scratch - Large / (R) Rear Fender, Molding - Scratch - Small / Rear Bumper, Lamps, Panels - Scratch &amp; Dent - Medium / Trunk Hood, Rear Gate - Scratch - Small / (L) Rear Fender, Molding - Repair mark - Yes / (L) Rear Fender, Molding - Scratch &amp; Dent - Large / (L) Rear Door, Molding - Repair mark - Yes / (L) Rear Door, Molding - Scratch &amp; Dent - Large / (L) Step, In-panel, Side Spoiler - Dent - Small / (L) Front Door, Molding - Scratch - Small / (L) Mirror - Scratch - Small / (L) Front Fender, Molding - Scratch - Minimal / Front Bumper, Grille, Lamps - Scratch &amp; Dent - Large / Member (Bolted) - Dent - Yes</p> |

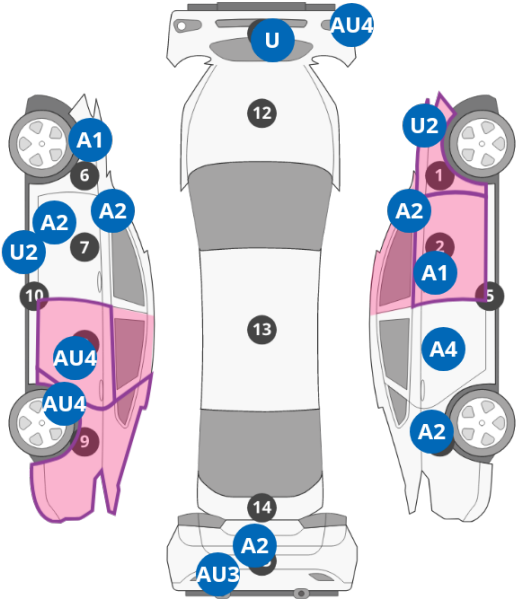
| Inspector Notes |
|---|
| <p>Gap on bonnet. Scratches on headlight and taillight. Yellow marks on signal light at front left fender. With Warranty booklet and spare tire. Without jack and seat cover. Incomplete tools. 2 keys. With LTO plate.</p> |
