## General Information

| Make | Toyota | Model | Wigo |
| Registration No. | CCP1336 | Chassis No. | MHKAA1BC1RJ033018 |

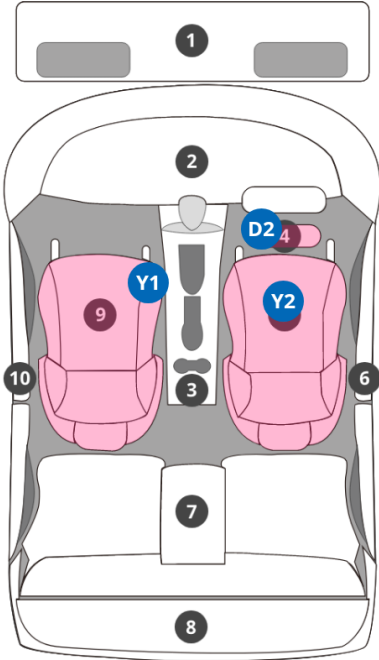
| Interior Evaluation : <span style="color: red; font-weight: bold;">A</span> | Exterior Evaluation : <span style="color: red; font-weight: bold;">C</span> |
| <b>Remarks</b><br>(L) Front Floor Mat - Worked - Small / (R) Front Seat - Grime - Small / (L) Front Seat - Grime - Minimal | <b>Remarks</b><br>(R) Rear Door, Molding - Scratch - Medium / Front Bumper, Grille, Lamps - Scratch - Large / (R) Front Door, Molding - Scratch - Small / (R) Rear Fender, Molding - Scratch - Minimal / Rear Bumper, Lamps, Panels - Scratch - Small / Trunk Hood, Rear Gate - Scratch - Small / (L) Rear Fender, Molding - Scratch - Minimal / (L) Rear Door, Molding - Scratch - Minimal / (L) Front Door, Molding - Scratch - Small |

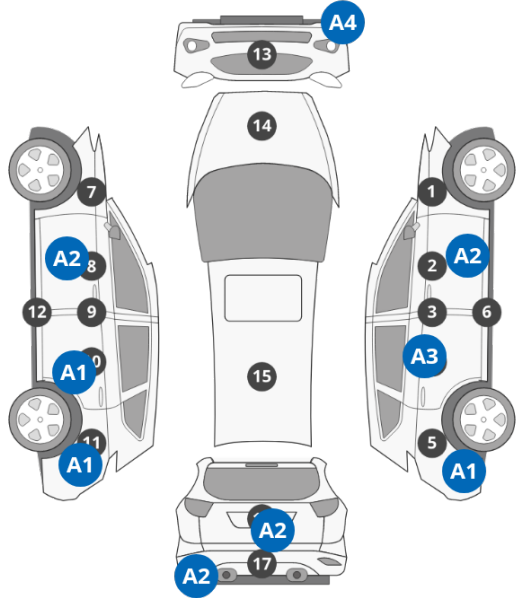
no tools/ with jack and spare tire/ with LTO plate and warranty booklet/ 2 keys/ light scratches around the exterior/
