## General Information

| Make | Toyota | Model | Hilux Tamaraw |
| YOM | 2026 | Odo Meter Reading | 14,761 |
| Registration No. | NLC4751 | Chassis No. | PAHACACA7S6431060 |

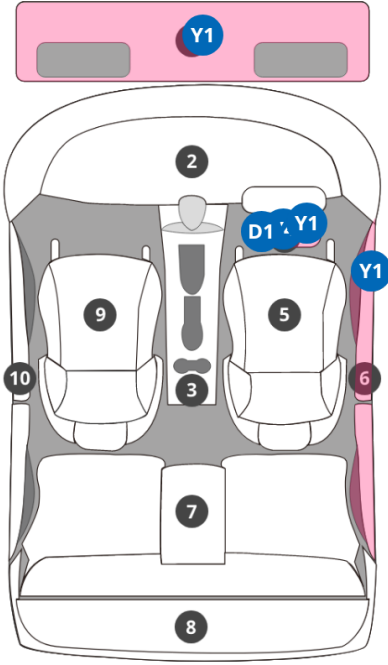
| Interior Evaluation : <span>C</span> | Exterior Evaluation : <span>C</span> |
|---|---|
| <b>Remarks</b><br>(L) Front Floor Mat - Grime - Large / Ceiling - Grime - Minimal / (R) Front Trim - Grime - Minimal / (R) Front Floor Mat - Grime - Minimal / Carpet - Worked - Minimal | <b>Remarks</b><br>(R) Front Fender, Molding - Scratch - Minimal / (R) Mirror - Scratch - Minimal / (R) Front Door, Molding - Scratch & Dent - Medium / (R) Step, In-panel, Side Spoiler - Scratch - Minimal / (R) Side Gate - Scratch - Small / Rear Gate - Scratch - Minimal / Rear Bumper, Lamps, Panels - Scratch - Minimal / Cargo Bed Floor - Scratch - Large / (L) Side Gate - Scratch - Medium / Roof - Scratch - Small / (L) Front Door, Molding - Scratch - Minimal / Front Bumper, Grille, Lamps - Scratch - Large / Bonnet, Headlight - Dent - Small |

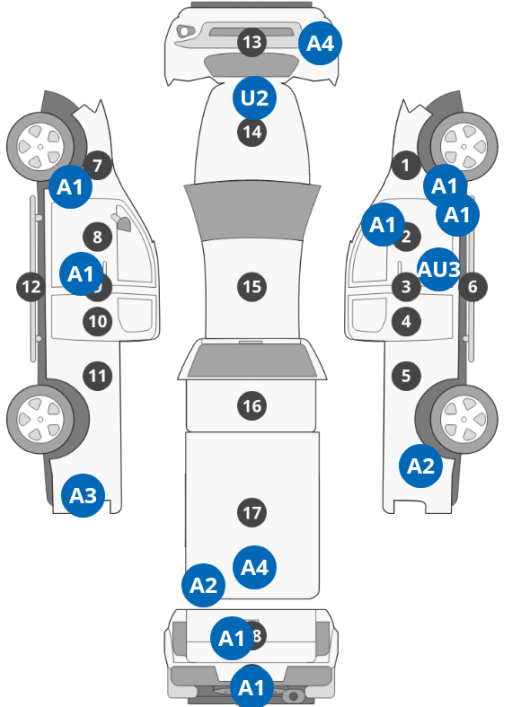
| Inspector Notes |
|---|
| No Lto plate, with spare tire and jack, 1key, no warranty booklet and tools, scratches on headlights |
