## General Information

| Make | Toyota | Model | Avanza |
| Registration No. | DCD7649 | Chassis No. | MHFAA1BY1S0048365 |

## Body / Panel Condition

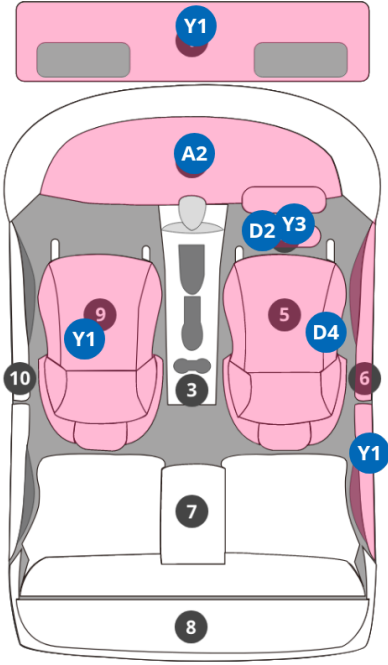
| Interior Evaluation : <span>C</span> | Exterior Evaluation : <span>C</span> |
| <b>Remarks</b><br>(R) Rear Trim - Grime - Minimal / Mat Other - Grime - Medium / Ceiling - Grime - Minimal / (L) Front Seat - Grime - Minimal / (L) Front Floor Mat - Worked - Small / (R) Front Seat belt - Loose, Deformed - Large / Steering Wheel - Worn, Peel, Crack - Small | <b>Remarks</b><br>(R) Mirror - Scratch - Minimal / (R) Front Door, Molding - Scratch - Minimal / (R) Rear Door, Molding - Scratch - Minimal / (R) Rear Fender, Molding - Scratch - Small / Rear Bumper, Lamps, Panels - Scratch - Minimal / Trunk Hood, Rear Gate - Scratch - Minimal / (L) Rear Fender, Molding - Scratch - Minimal / (L) Rear Door, Molding - Scratch & Dent - Small / (L) Front Door, Molding - Scratch - Minimal / (L) Front Fender, Molding - Scratch - Minimal / Front Bumper, Grille, Lamps - Scratch & Dent - Large / Bonnet, Headlight - Scratch - Minimal |
