## General Information

| Make | Toyota | Model | Fortuner |
| YOM | 2024 | Odo Meter Reading | 46,059 |
| Registration No. | BAG5879 | Chassis No. | MHFCB3GS1R0496587 |

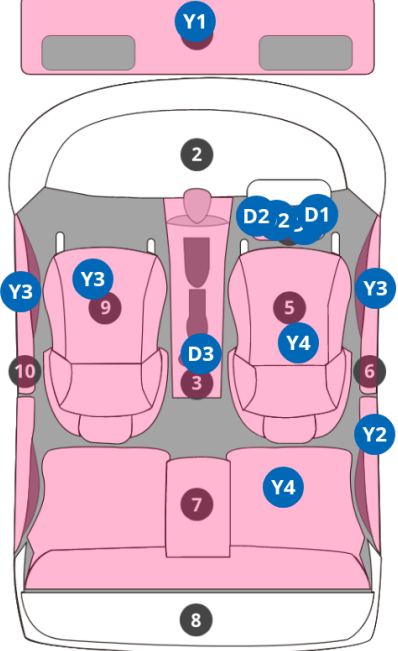
| Interior Evaluation : <b>E</b> | Exterior Evaluation : <b>E</b> |
| <p><b>a</b> : Cut, Fray <b>d</b> : Loose, Deformed <b>k</b> : Animal Hair <b>s</b> : Smell <b>t</b> : Cigarette Burns <b>x</b> : Defective <b>y</b> : Stain</p> | <p><b>A</b> : Scratch <b>AU</b> : Scratch &amp; Dent <b>B</b> : Modified <b>C</b> : Corrosion <b>G</b> : Stone chip <b>P</b> : Faded <b>S</b> : Rust <b>SC</b> : Rust &amp; Corrosion <b>U</b> : Dent <b>X</b> : Defective <b>Y</b> : Crack, Gap</p> |
| <p><b>Remarks</b></p> <p>Rear Seat - Grime - Large / Ceiling - Grime - Minimal / Mat Other - Worked - Small / (R) Rear Trim - Grime - Small / (R) Front Trim - Grime - Medium / (R) Front Seat - Grime - Large / (R) Front Floor Mat - Worked - Small / (L) Front Trim - Grime - Medium / (L) Front Seat - Grime - Medium / (L) Front Floor Mat - Worked - Small / Carpet - Worked - Minimal / Console, Switchs, Vents - Loose, Deformed - Medium</p> | <p><b>Remarks</b></p> <p>(R) Front Fender, Molding - Scratch - Large / (R) Mirror - Scratch - Minimal / (R) Front Door, Molding - Scratch &amp; Dent - Large / (R) Rear Door, Molding - Scratch - Large / (R) Step, In-panel, Side Spoiler - Scratch - Medium / (R) Rear Fender, Molding - Scratch - Large / Rear Bumper, Lamps, Panels - Scratch &amp; Dent - Large / Trunk Hood, Rear Gate - Scratch - Medium / (L) Rear Fender, Molding - Scratch &amp; Dent - Large / (L) Rear Door, Molding - Scratch &amp; Dent - Large / (L) Front Door, Molding - Scratch &amp; Dent - Large / (L) Front Fender, Molding - Scratch &amp; Dent - Large / Front Bumper, Grille, Lamps - Crack, Gap - Large / Bonnet, Headlight - Scratch &amp; Dent - Large / Member (Bolted) - Dent - Yes / Roof Spoiler, Molding - Scratch - Minimal / (L) Mirror - Crack - Cracks / (L) Step, In-panel, Side Spoiler - Crack, Gap - Large</p> |

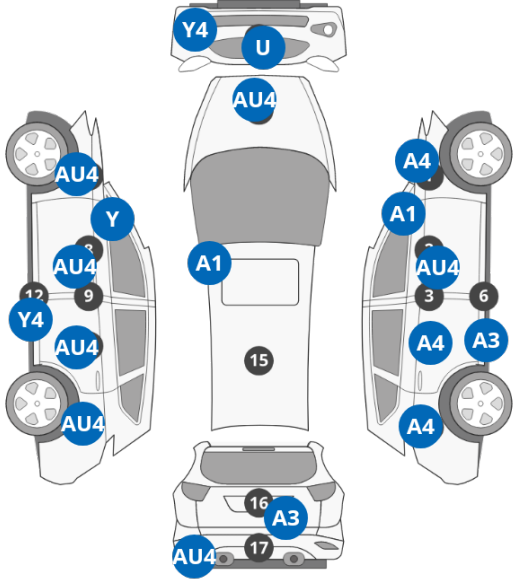
| Inspector Notes |
|---|
| With Lto plate, with spare tire and jack, 2keys, no warranty booklet and tools, Crack headlight, scratches on taillights, Left front door gap,plate light issue |
