## General Information

| Make | Toyota | Model | Hilux Tamaraw |
| Registration No. | NJG1614 | Chassis No. | PAHACACA7S6439779 |

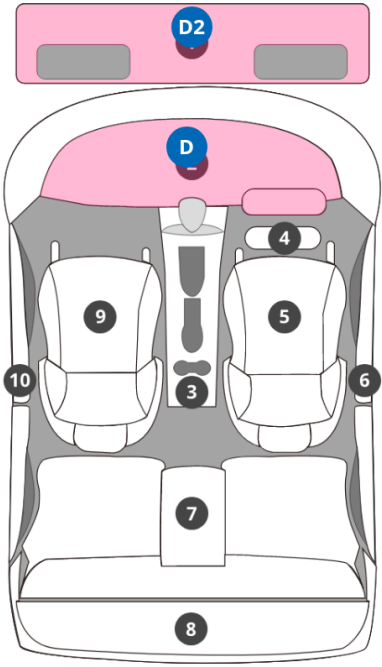
| Interior Evaluation : <span style="color: red; font-weight: bold;">A</span> | Exterior Evaluation : <span style="color: red; font-weight: bold;">D</span> |
|---|---|
| <b>Remarks</b><br>Ceiling - Loose, Deformed - Small / Dashboard - Traces of Adhesive Tape - Yes | <b>Remarks</b><br>(R) Mirror - Scratch - Minimal / (R) Front Fender, Molding - Scratch - Minimal / (R) Front Door, Molding - Scratch & Dent - Small / (R) Side Gate - Scratch & Dent - Large / Rear Bumper, Lamps, Panels - Scratch & Dent - Minimal / Rear Gate - Scratch - Minimal / (L) Side Gate - Scratch & Dent - Large / Roof - Scratch - Small / (L) Front Door, Molding - Scratch & Dent - Medium / (L) Step, In-panel, Side Spoiler - Scratch - Minimal / (L) Mirror - Scratch, Peeled - Yes / (L) Front Fender, Molding - Scratch - Minimal / Front Bumper, Grille, Lamps - Scratch - Large / Bonnet, Headlight - Scratch - Minimal |
