## General Information

| Make | Toyota | Model | Vios |
| YOM | 2025 | Odo Meter Reading | 4,210 |

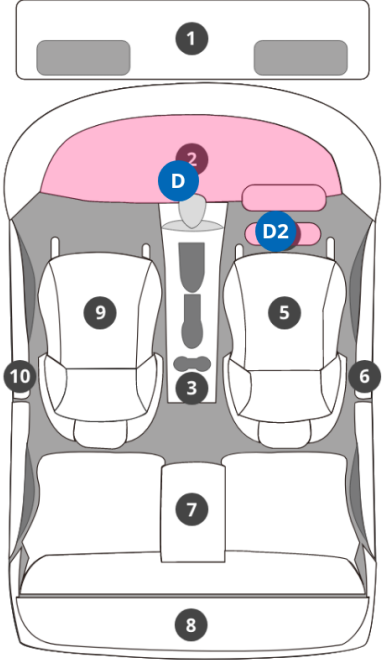
| Interior Evaluation : <b>A</b> | Exterior Evaluation : <b>D</b> |
|---|---|
| <b>Remarks</b><br>Dashboard - Traces of Adhesive Tape - Yes / (L) Front Floor Mat - Worked - Small | <b>Remarks</b><br>Front Bumper, Grille, Lamps - Scratch & Dent - Large / Bonnet, Headlight - Crack, Gap - Large / Rear Bumper, Lamps, Panels - Scratch - Medium / (L) Front Door, Molding - Scratch - Small / (L) Rear Fender, Molding - Scratch - Minimal / (R) Rear Door, Molding - Scratch - Small / (L) Rear Door, Molding - Scratch - Small / (L) Front Fender, Molding - Scratch - Small / (R) Front Fender, Molding - Scratch - Small / (R) Rear Fender, Molding - Scratch - Small / Trunk Hood, Rear Gate - Scratch - Small / (R) Front Door, Molding - Dent - Small / Roof - Scratch - Small |
