## General Information

| Make | Toyota | Model | Vios |
| YOM | 2024 | Mileage | 12,905 |
| Registration No. | EAJ2598 | Chassis No. | PA1B18F35R4252911 |

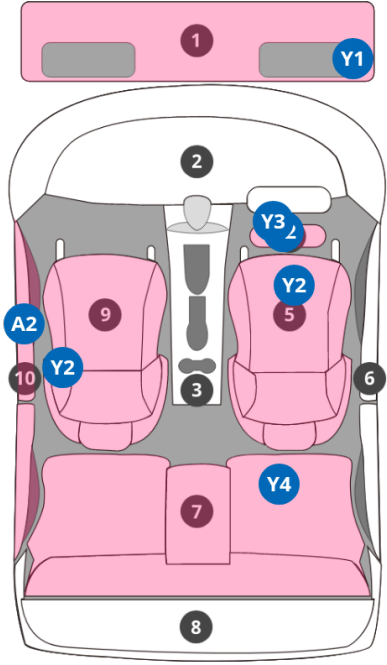
| Interior Evaluation : <b>C</b> | Exterior Evaluation : <b>A</b> |
| <p><b>Remarks</b><br/>Rear Seat - Grime - Large / (R) Front Seat - Grime - Small / (L) Front Seat - Grime - Small / (L) Front Floor Mat - Worked - Small / (L) Front Floor Mat - Grime - Medium / Ceiling - Grime - Minimal / (L) Front Trim - Cut, Crack - Small</p> | <p><b>Remarks</b><br/>(R) Rear Door, Molding - Dent - Small / (R) Rear Fender, Molding - Scratch - Small / Rear Bumper, Lamps, Panels - Scratch - Minimal / Trunk Hood, Rear Gate - Scratch - Minimal / Front Bumper, Grille, Lamps - Crack, Gap - Small / Bonnet, Headlight - Scratch - Minimal</p> |
