## General Information

| Make | Toyota | Model | Hilux Tamaraw |
| Registration No. | DCC8413 | Chassis No. | PAHACACA4S6428424 |

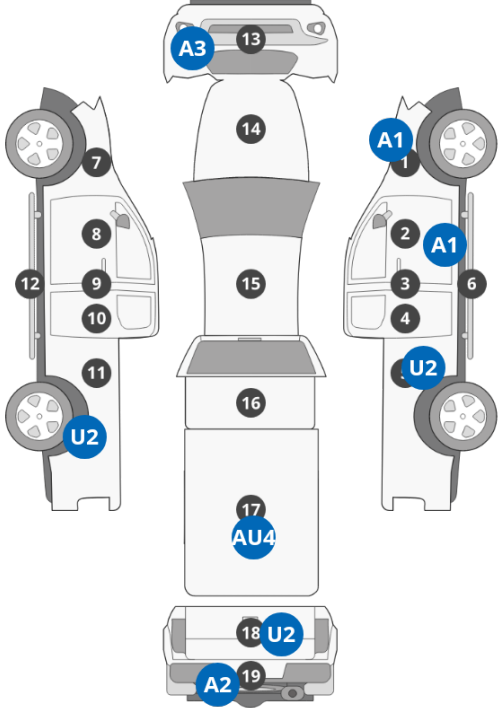
| Interior Evaluation : <span style="color: red; font-weight: bold;">A</span> | Exterior Evaluation : <span style="color: red; font-weight: bold;">C</span> |
|---|---|
| <b>Remarks</b><br>Defects not found | <b>Remarks</b><br>Front Bumper, Grille, Lamps - Scratch - Medium / Cargo Bed Floor - Scratch & Dent - Large / Rear Gate - Dent - Small / (R) Side Gate - Dent - Small / (L) Side Gate - Dent - Small / (R) Front Door, Molding - Scratch - Minimal / (R) Front Fender, Molding - Scratch - Minimal / Rear Bumper, Lamps, Panels - Scratch - Small |

no tools/ light scratches around the exterior/ with jack and spare tire/ with warranty booklet and LTO plate/ 4 keys
