## General Information

| Make | Toyota | Model | Vios |

## Body / Panel Condition

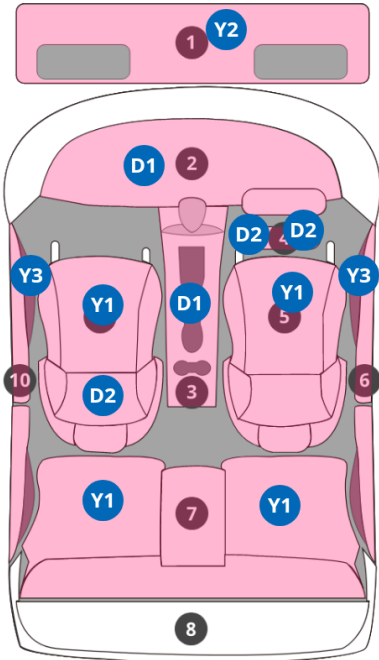
| Interior Evaluation : <span style="color: red;">C</span> | Exterior Evaluation : <span style="color: red;">C</span> |
| <p><b>Remarks</b></p> <p>(R) Front Floor Mat - Worked - Small / (L) Front Floor Mat - Worked - Small / (L) Front Trim - Grime - Medium / Rear Seat - Grime - Minimal / Trim Other - Grime - Minimal / (L) Front Seat Head Rest - Worked - Small / Console, Switches, Vents - Worked - Minimal / (R) Front Seat - Grime - Minimal / (L) Front Seat - Grime - Minimal / Dashboard - Worked - Minimal / Ceiling - Grime - Small / (R) Front Trim - Grime - Medium</p> | <p><b>Remarks</b></p> <p>Bonnet - Repair Traces - Yes / Trunk Hood, Rear Gate - Repair Traces - Yes / Roof - Repair Traces - Yes / (R) Front Fender, Molding - Scratch - Minimal / (R) Front Door, Molding - Scratch - Minimal / (R) Step, In-panel, Side Spoiler - Scratch - Minimal / Trunk Hood, Rear Gate - Modified - Large / (L) Rear Door, Molding - Dent - Minimal / (L) Front Door, Molding - Scratch - Minimal / Roof - Modified - Large / Front Bumper, Grille, Lamps - Scratch - Small / Bonnet, Headlight - Modified - Large</p> |

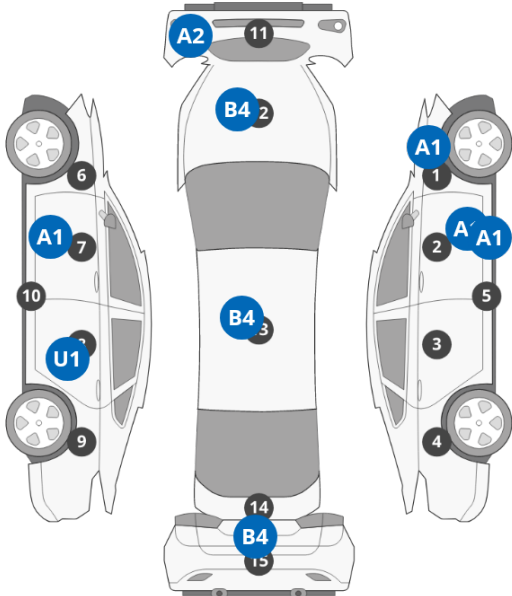
with Ito plate/with tools no jack/without spare tire/with reverse camera/modified rear trunk,roof,hood/with hairlines scratches on the body/no spare key
