## General Information

| Make | Toyota | Model | Wigo |
| YOM | 2025 | Odo Meter Reading | 11,818 |
| Registration No. | GBB3366 | Chassis No. | MHKAA1BC0SJ037695 |

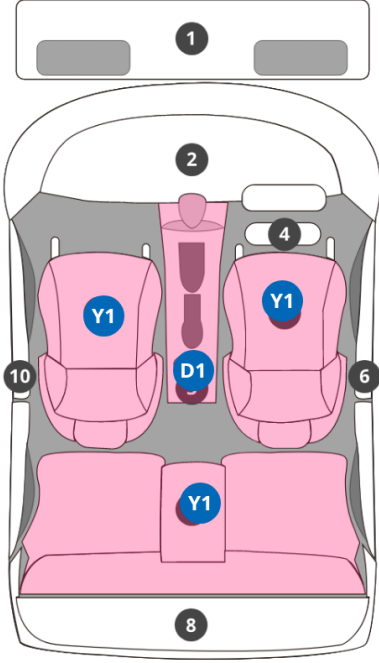
| Interior Evaluation : <b>A</b> | Exterior Evaluation : <b>D</b> |
| <p><b>Remarks</b><br/>(R) Front Seat - Grime - Minimal / (L) Front Seat - Grime - Minimal / Rear Seat - Grime - Minimal / Console, Switchs, Vents - Loose, Deformed - Minimal</p> | <p><b>Remarks</b><br/>Trunk Hood, Rear Gate - Repair Traces - Yes / (R) Front Fender, Molding - Scratch - Minimal / (R) Front Door, Molding - Scratch - Small / (R) Rear Door, Molding - Scratch - Small / (R) Step, In-panel, Side Spoiler - Scratch &amp; Dent - Medium / (R) Rear Fender, Molding - Scratch - Minimal / (L) Front Fender, Molding - Scratch - Minimal / (L) Front Door, Molding - Scratch - Small / (L) Step, In-panel, Side Spoiler - Scratch - Small / (L) Rear Door, Molding - Scratch - Small / (L) Rear Fender, Molding - Scratch - Minimal / Front Bumper, Grille, Lamps - Crack, Gap - Medium / Bonnet, Headlight - Scratch - Minimal / Trunk Hood, Rear Gate - Dent - Medium / Rear Bumper, Lamps, Panels - Crack, Gap - Large</p> |
