## General Information

| Make | Toyota | Model | Vios |
| YOM | 2024 | Odo Meter Reading | 23,081 |

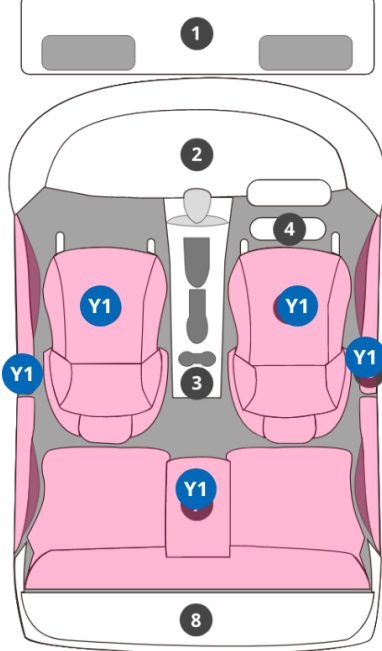
| <b>Interior Evaluation :</b> <b>A</b> | <b>Exterior Evaluation :</b> <b>D</b> |
| <b>Remarks</b><br>(R) Front Seat - Grime - Minimal / (L) Front Seat - Grime - Minimal / (L) Front Trim - Grime - Minimal / (R) Front Trim - Grime - Minimal / Rear Seat - Grime - Minimal | <b>Remarks</b><br>(R) Front Fender, Molding - Rust, Corrosion - Medium / (R) Mirror - Scratch - Minimal / (R) Rear Door, Molding - Scratch - Minimal / (R) Rear Fender, Molding - Dent - Small / (L) Front Fender, Molding - Scratch - Minimal / (L) Front Door, Molding - Scratch - Minimal / (L) Rear Door, Molding - Scratch - Small / (L) Step, In-panel, Side Spoiler - Scratch - Minimal / (L) Rear Fender, Molding - Scratch - Minimal / Front Bumper, Grille, Lamps - Scratch & Dent - Large / Bonnet, Headlight - Rust, Corrosion - Small / Trunk Hood, Rear Gate - Scratch - Small / Rear Bumper, Lamps, Panels - Scratch - Small / (R) Front Door, Molding - Scratch - Medium / (R) Side Window - Scratch, Stone chip - Small / Rear Windshield - Scratch, Stone chip - Small |
