## General Information

| Make | Toyota | Model | Wigo |
| YOM | 2025 | Odo Meter Reading | 37,332 |
| Registration No. | KAU4225 | Chassis No. | MHKAA1BC1RJ032709 |

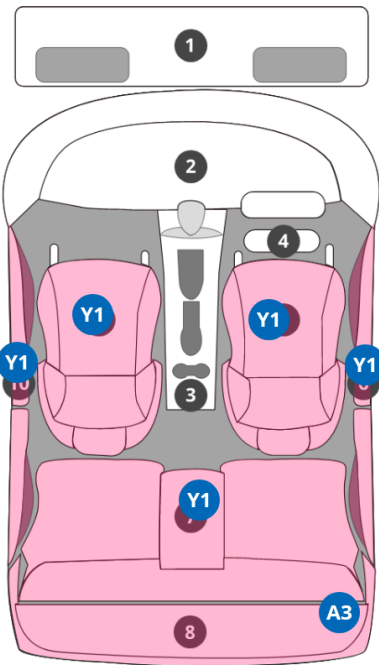
| Interior Evaluation : <span style="color: red; font-weight: bold;">B</span> | | Exterior Evaluation : <span style="color: red; font-weight: bold;">C</span> | |
| <p><b>Remarks</b></p> <p>(L) Front Seat - Grime - Minimal / (R) Front Seat - Grime - Minimal / Rear Seat - Grime - Minimal / (L) Front Trim - Grime - Minimal / (R) Front Trim - Grime - Minimal / Trunk Room - Worn, Scratch, Cut, Crack - Medium</p> | | <p><b>Remarks</b></p> <p>(R) Front Fender, Molding - Scratch - Small / (R) Mirror - Scratch - Minimal / (R) Side Window - Scratch, Stone chip - Small / (R) Front Door, Molding - Scratch - Minimal / (R) Step, In-panel, Side Spoiler - Scratch - Small / (R) Rear Door, Molding - Scratch &amp; Dent - Medium / (R) Rear Fender, Molding - Scratch - Minimal / (L) Front Fender, Molding - Scratch - Minimal / (L) Step, In-panel, Side Spoiler - Scratch - Minimal / (L) Front Door, Molding - Scratch - Small / (L) Rear Door, Molding - Scratch - Small / (L) Rear Fender, Molding - Scratch - Minimal / Front Bumper, Grille, Lamps - Scratch - Small / Bonnet, Headlight - Scratch - Minimal / Trunk Hood, Rear Gate - Scratch - Minimal / Rear Bumper, Lamps, Panels - Scratch - Minimal</p> | |
