## General Information

| Make | Toyota | Model | Fortuner |
| Registration No. | NHC5061 - NO ORCR | Chassis No. | MHFCB8GS8N0528118 |

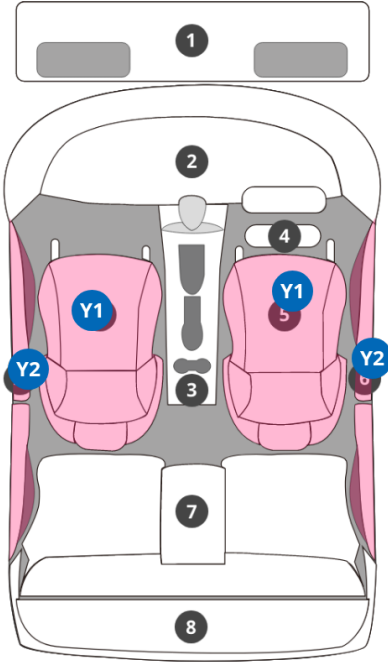
| Interior Evaluation : <span style="color: red; font-weight: bold;">A</span> | Exterior Evaluation : <span style="color: red; font-weight: bold;">D</span> |
| <b>Remarks</b><br>(R) Front Seat - Grime - Minimal / (L) Front Seat - Grime - Minimal / (L) Front Trim - Grime - Small / (R) Front Trim - Grime - Small | <b>Remarks</b><br>(R) Front Fender, Molding - Scratch - Minimal / (R) Front Door, Molding - Scratch - Small / (R) Step, In-panel, Side Spoiler - Scratch - Minimal / (R) Rear Door, Molding - Scratch - Small / (R) Rear Fender, Molding - Scratch - Minimal / (L) Front Fender, Molding - Scratch - Small / (L) Front Door, Molding - Scratch & Dent - Large / (L) Step, In-panel, Side Spoiler - Crack, Gap - Medium / (L) Rear Door, Molding - Scratch - Small / (L) Rear Fender, Molding - Scratch - Medium / Front Bumper, Grille, Lamps - Scratch - Small / Bonnet, Headlight - Scratch - Minimal / Trunk Hood, Rear Gate - Scratch - Medium / Rear Bumper, Lamps, Panels - Scratch - Small |
