## General Information

| Make | Toyota | Model | Vios |
| Registration No. | ZAD4903 | Chassis No. | PA1B18F32R4272338 |

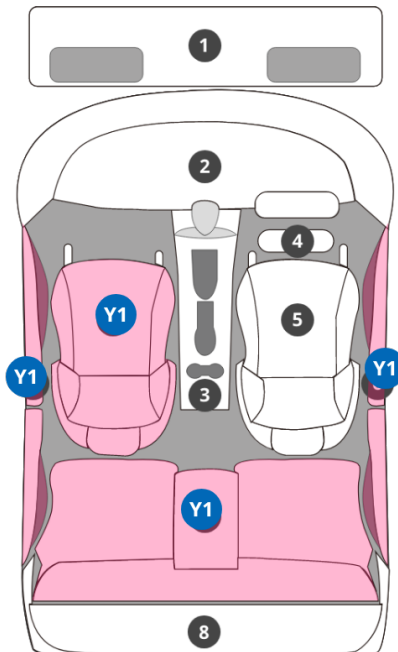
| Interior Evaluation : <span style="color: red; font-weight: bold;">A</span> | Exterior Evaluation : <span style="color: red; font-weight: bold;">D</span> |
| <b>Remarks</b><br>Rear Seat - Grime - Minimal / (L) Front Trim - Grime - Minimal / (R) Front Trim - Grime - Minimal / (L) Front Seat - Grime - Minimal | <b>Remarks</b><br>(R) Front Fender, Molding - Scratch - Small / (R) Front Door, Molding - Scratch - Minimal / (R) Rear Door, Molding - Scratch - Medium / (R) Step, In-panel, Side Spoiler - Scratch & Dent - Large / (R) Rear Fender, Molding - Rust, Corrosion - Minimal / (L) Front Fender, Molding - Scratch - Small / (L) Mirror - Scratch - Minimal / (L) Front Door, Molding - Rust, Corrosion - Medium / (L) Rear Door, Molding - Scratch - Minimal / (L) Step, In-panel, Side Spoiler - Scratch - Small / (L) Rear Fender, Molding - Scratch - Minimal / Front Bumper, Grille, Lamps - Scratch & Dent - Medium / Bonnet, Headlight - Scratch - Minimal / Trunk Hood, Rear Gate - Scratch - Minimal / Rear Bumper, Lamps, Panels - Scratch - Small |
