## General Information

| Make | Toyota | Model | Vios |
| Registration No. | A8E625 | Chassis No. | PA1B23F38J6005424 |

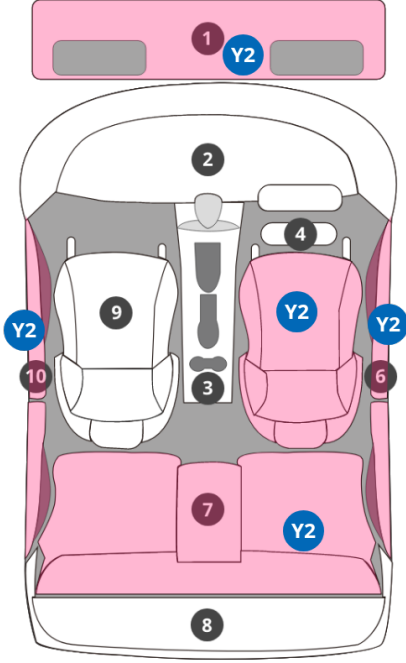
| Interior Evaluation : <b>B</b> | Exterior Evaluation : <b>B</b> |
| <p><b>Remarks</b><br/>(L) Front Trim - Grime - Small / (R) Front Trim - Grime - Small / (R) Front Seat - Grime - Small / Rear Seat - Grime - Small / Ceiling - Grime - Small</p> | <p><b>Remarks</b><br/>Bonnet - Repair Traces - Yes / (L) Step - Repair Traces - Yes / (L) Front Door, Molding - Dent - Small / (L) Rear Door, Molding - Scratch - Small / (R) Front Door, Molding - Scratch &amp; Dent - Small / (R) Rear Door, Molding - Scratch - Small / Bonnet, Headlight - Scratch - Small / Trunk Hood, Rear Gate - Scratch - Small</p> |
