## General Information

| Make | Toyota | Model | Vios |

## Body / Panel Condition

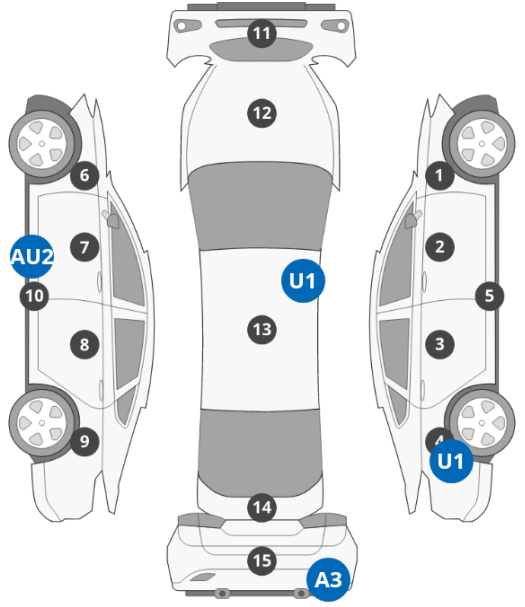
| Interior Evaluation : <b>A</b> | Exterior Evaluation : <b>B</b> |
|---|---|
| <b>Remarks</b><br>Defects not found | <b>Remarks</b><br>Roof - Dent - Minimal / (L) Step, In-panel, Side Spoiler - Scratch & Dent - Small / Rear Bumper, Lamps, Panels - Scratch - Medium / (R) Rear Fender, Molding - Dent - Minimal |

minimal hairline scratches/ good condition
