## General Information

| Make | Toyota | Model | Hiace |
| Registration No. | NBP1428 | Chassis No. | JTFRT13P4J8029458 |

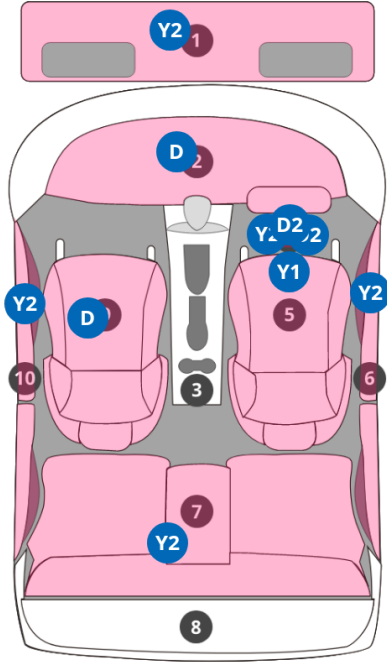
| Interior Evaluation : <b>C</b> | Exterior Evaluation : <b>E</b> |
| <p><b>Remarks</b></p> <p>(R) Front Seat - Grime - Minimal / (L) Front Seat - Worn - Yes / (L) Front Trim - Grime - Small / (R) Front Trim - Grime - Small / Rear Seat - Grime - Small / (L) Front Floor Mat - Grime - Small / (R) Front Floor Mat - Crinkle - Small / Mat Other - Worked - Small / Dashboard - Traces of Adhesive Tape - Yes / Ceiling - Grime - Small</p> | <p><b>Remarks</b></p> <p>Trunk Hood, Rear Gate - Repair Traces - Yes / Roof - Scratch - Medium / (R) Front Door, Molding - Scratch &amp; Dent - Small / (R) Step, In-panel, Side Spoiler - Scratch &amp; Dent - Minimal / (R) Center Panel - Scratch &amp; Dent - Small / (R) Rear Door, Molding - Scratch &amp; Dent - Small / (R) Rear Fender, Molding - Scratch &amp; Dent - Medium / Trunk Hood, Rear Gate - Repair mark - Yes / Trunk Hood, Rear Gate - Crack, Gap - Medium / Rear Bumper, Lamps, Panels - Repair mark - Yes / Rear Bumper, Lamps, Panels - Scratch - Small / (L) Rear Fender, Molding - Scratch &amp; Dent - Small / (L) Rear Door, Molding - Scratch &amp; Dent - Small / (L) Front Door, Molding - Scratch &amp; Dent - Small / (L) Front Fender, Molding - Scratch &amp; Dent - Minimal / Front Panel - Scratch &amp; Dent - Small / Front Bumper, Grille, Lamps - Scratch - Small / (L) Step, In-panel, Side Spoiler - Scratch &amp; Dent - Small / (R) Front Fender, Molding - Scratch - Minimal</p> |

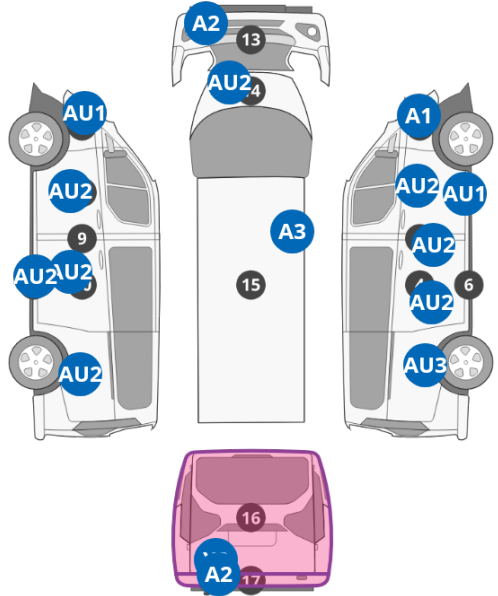
with LTO plate, with spare tire, with reverse camera, with warranty and manual booklet, no tools and jack, issue on retractable mirror right side, scratches and dent on exterior, scratches on taillight and headlight, aircon freon issue.
