## General Information

| Make | Toyota | Model | Innova |
| Registration No. | APA7081 | Chassis No. | KUN405117777 |

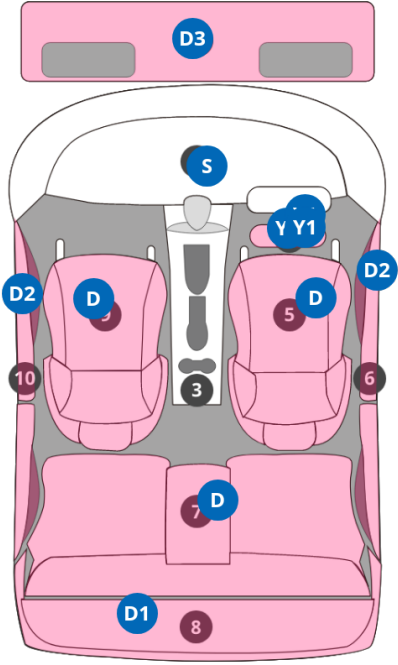
| Interior Evaluation : <b>C</b> | Exterior Evaluation : <b>E</b> |
| <p><b>Remarks</b></p> <p>(R) Front Seat - Worn - Yes / (L) Front Seat - Worn - Yes / Rear Seat - Worn - Yes / (L) Front Trim - Worked - Small / (R) Front Trim - Worked - Small / (R) Front Floor Mat - Grime - Minimal / (L) Front Floor Mat - Grime - Minimal / Mat Other - Grime - Minimal / Ceiling - Crinkle - Medium / Trunk Room - Worked - Minimal / Overall Interior - Smell - Yes</p> | <p><b>Remarks</b></p> <p>(R) Front Door - Repair Traces - Yes / (R) Step - Repair Traces - Yes / (R) Front Fender - Repair Traces - Yes / Bonnet - Repair Traces - Yes / (L) Front Fender - Repair Traces - Yes / (L) Step - Repair Traces - Yes / Trunk Hood, Rear Gate - Repair Traces - Yes / (R) Rear Fender - Repair Traces - Yes / (R) Rear Door - Repair Traces - Yes / (R) Rear Door, Molding - Repair mark - Yes / (R) Front Door, Molding - Repair mark - Yes / (R) Rear Fender, Molding - Repair mark - Yes / Trunk Hood, Rear Gate - Repair mark - Yes / Rear Bumper, Lamps, Panels - Repair mark - Yes / (R) Rear Fender, Molding - Scratch &amp; Dent - Small / (R) Rear Door, Molding - Scratch &amp; Dent - Small / (R) Front Door, Molding - Scratch &amp; Dent - Medium / (R) Front Fender, Molding - Scratch &amp; Dent - Small / (R) Step, In-panel, Side Spoiler - Scratch &amp; Dent - Small / Bonnet, Headlight - Scratch &amp; Dent - Small / Front Bumper, Grille, Lamps - Scratch &amp; Dent - Medium / (L) Front Fender, Molding - Scratch &amp; Dent - Small / (L) Front Door, Molding - Scratch &amp; Dent - Small / (L) Rear Door, Molding - Scratch &amp; Dent - Small / (L) Step, In-panel, Side Spoiler - Scratch &amp; Dent - Medium / (L) Rear Fender, Molding - Scratch &amp; Dent - Small / Roof - Scratch &amp; Dent - Small / Overall Exterior - Full Re-Paint in same color - Yes / Trunk Hood, Rear Gate - Scratch &amp; Dent - Small / Rear Bumper, Lamps, Panels - Scratch - Small</p> |

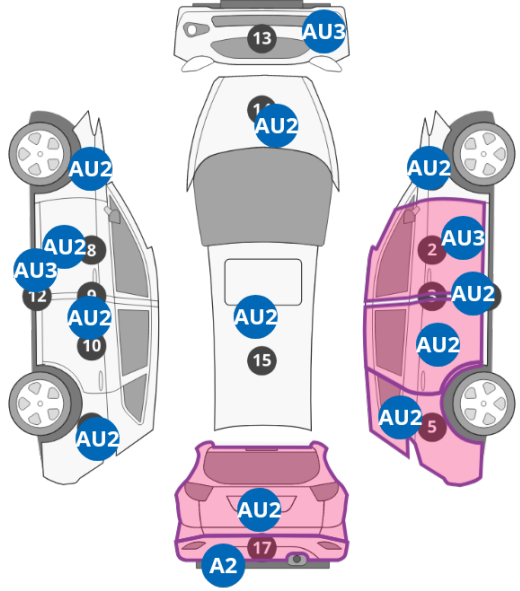
with LTO plate, with spare tire, no warranty and manual booklet, no jack and tools, no reverse camera, no spare key, scratches and dent on exterior, scratches on taillight and headlight, crack issue on taillight.
