## General Information

| Make | Toyota | Model | Wigo |
| YOM | 2023 | Odo Meter Reading | 41,500 |

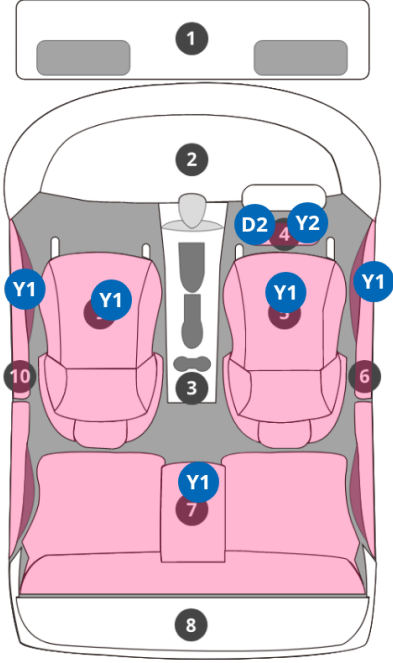
| Interior Evaluation : <span style="color: red; font-weight: bold;">A</span> | Exterior Evaluation : <span style="color: red; font-weight: bold;">D</span> |
|---|---|
| <b>Remarks</b><br>(R) Front Trim - Grime - Minimal / (R) Front Floor Mat - Grime - Small / (L) Front Trim - Grime - Minimal / (L) Front Floor Mat - Worked - Small / Rear Seat - Grime - Minimal / (R) Front Seat - Grime - Minimal / (L) Front Seat - Grime - Minimal | <b>Remarks</b><br>(R) Step - Repair Traces - Yes / (R) Step - Replaced - Yes / (R) Front Fender - Repair Traces - Yes / (L) Front Fender - Repair Traces - Yes / (L) Rear Door - Repair Traces - Yes / (R) Rear Fender - Repair Traces - Yes / (R) Rear Fender - Replaced - Yes / (R) Rear Door - Repair Traces - Yes / (R) Front Door, Molding - Repair mark - Yes / (R) Rear Door, Molding - Repair mark - Yes / Bonnet, Headlight - Scratch - Small / Front Bumper, Grille, Lamps - Scratch - Medium / (L) Front Fender, Molding - Scratch - Small / (L) Step, In-panel, Side Spoiler - Scratch & Dent - Small / (L) Front Door, Molding - Scratch & Dent - Small / (L) Rear Door, Molding - Scratch - Small / (L) Rear Fender, Molding - Scratch - Small / Rear Bumper, Lamps, Panels - Crack, Gap - Small / Trunk Hood, Rear Gate - Scratch - Minimal / (R) Rear Fender, Molding - Crack, Gap - Small / (R) Rear Door, Molding - Scratch - Small / (R) Front Door, Molding - Scratch - Small / (R) Front Fender, Molding - Scratch - Minimal / Roof - Scratch & Dent - Small |

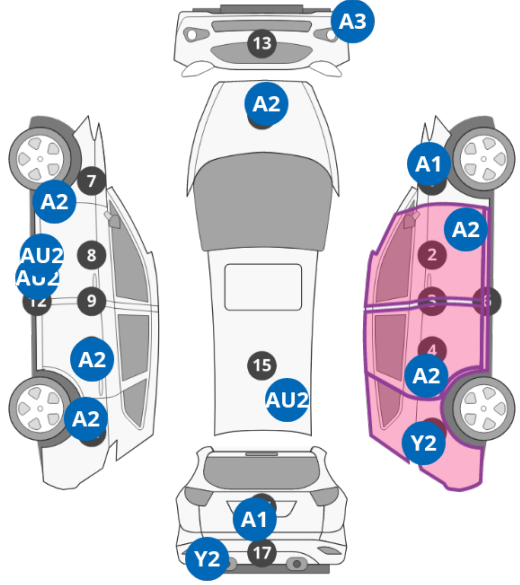
| Interior Evaluation : <span style="color: red; font-weight: bold;">A</span> | Exterior Evaluation : <span style="color: red; font-weight: bold;">D</span> |
|---|---|
| <b>Remarks</b><br>Right Tyre House - Traces of Bending, or Marks of Panel Repair ? - Yes / Rear Side Member & Trunk Room Floor - Condition of Welding, Hardness and Shape of Sealant ? - Yes | <b>Remarks</b><br>Battery - Weak - Yes / Spare Key - Issue - Unexist |
