## General Information

| Make | Toyota | Model | Wigo |
| Registration No. | NEV3727 | Chassis No. | MHKA4DF5FMJ059592 |

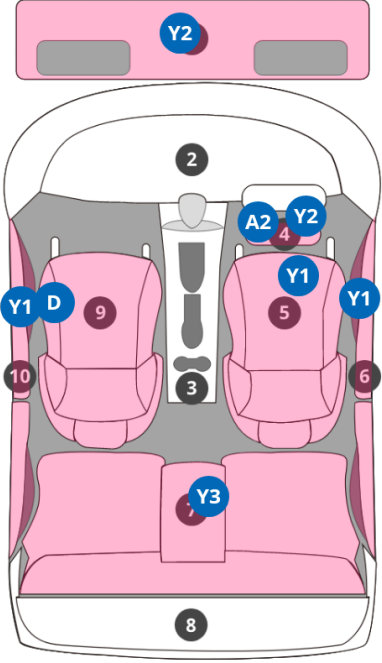
| <b>Interior Evaluation :</b> <span style="color: red; font-weight: bold;">B</span> | <b>Exterior Evaluation :</b> <span style="color: red; font-weight: bold;">E</span> |
| <b>Remarks</b><br>Rear Seat - Grime - Medium / (R) Front Trim - Grime - Minimal / (R) Front Seat - Grime - Minimal / (R) Front Floor Mat - Grime - Small / (L) Front Floor Mat - Cut, Crack - Small / (L) Front Seat - Worn - Yes / Ceiling - Grime - Small / (L) Front Trim - Grime - Minimal | <b>Remarks</b><br>(L) Front Fender, Molding - Scratch - Small / Front Bumper, Grille, Lamps - Scratch - Large / (L) Mirror - Scratch - Small / (L) Step, In-panel, Side Spoiler - Scratch - Small / (L) Front Door, Molding - Scratch - Small / (L) Rear Door, Molding - Scratch - Small / (L) Rear Fender, Molding - Crack, Gap - Medium / Rear Bumper, Lamps, Panels - Scratch - Large / Trunk Hood, Rear Gate - Scratch - Small / (R) Rear Fender, Molding - Crack, Gap - Medium / (R) Rear Door, Molding - Scratch - Medium / (R) Step, In-panel, Side Spoiler - Scratch - Small / (R) Front Door, Molding - Scratch & Dent - Small / (R) Mirror - Scratch - Medium / (R) Front Fender, Molding - Scratch & Dent - Small / Bonnet, Headlight - Scratch - Small / Roof - Scratch - Small |

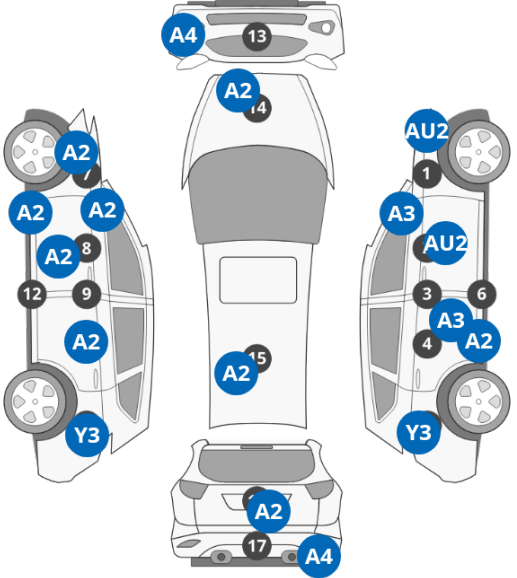
| Inspector Notes |
|---|
| with LTO plate/no warranty booklet/with incomplete tools with jack/with spare tire/passenger grab bar issue/scratches on headlight cover/hairline scratches on the body |
