## General Information

| Make | Toyota | Model | Hiace |
| Registration No. | NFR3160 | Chassis No. | JTFNAFAP5P8040224 |

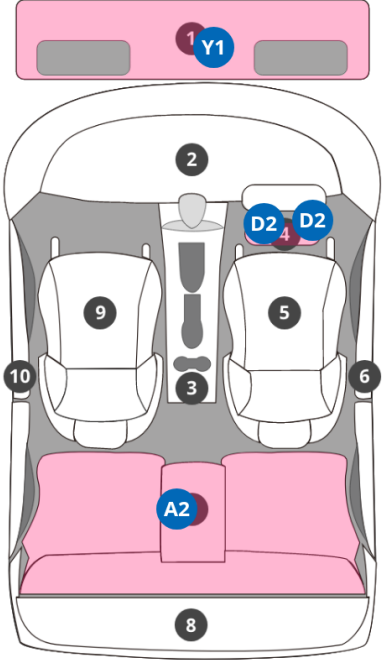
| Interior Evaluation : <b>A</b> | Exterior Evaluation : <b>D</b> |
| <b>Remarks</b><br>(L) Front Floor Mat - Worked - Small / (R) Front Floor Mat - Worked - Small / Ceiling - Grime - Minimal / Rear Seat - Cut, Crack - Small | <b>Remarks</b><br>Bonnet - Repair Traces - Yes / (L) Front Fender, Molding - Scratch - Minimal / (L) Mirror - Scratch - Minimal / (L) Step, In-panel, Side Spoiler - Scratch - Minimal / (L) Front Door, Molding - Scratch - Minimal / (L) Rear Fender, Molding - Scratch - Small / Rear Bumper, Lamps, Panels - Scratch - Small / Trunk Hood, Rear Gate - Scratch - Small / (R) Rear Fender, Molding - Scratch - Minimal / (R) Rear Door, Molding - Scratch & Dent - Medium / (R) Step, In-panel, Side Spoiler - Scratch & Dent - Large / (R) Center Panel - Scratch - Small / (R) Front Door, Molding - Scratch & Dent - Small / (R) Front Fender, Molding - Scratch & Dent - Small / (R) Mirror - Scratch - Minimal / Front Bumper, Grille, Lamps - Scratch - Small / Bonnet, Headlight - Scratch - Minimal / Roof - Scratch - Small |

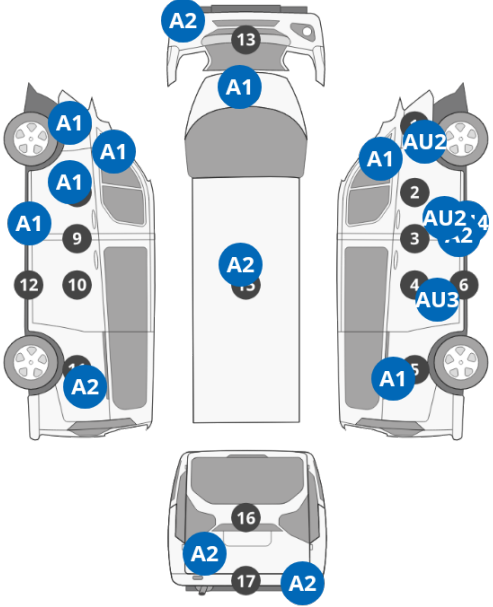
with LTO plate/no warranty booklet/no tools with jack/with spare tire/hairline scratches on the body/crack on taillight cover
