## General Information

| Make | Toyota | Model | Vios |

## Body / Panel Condition

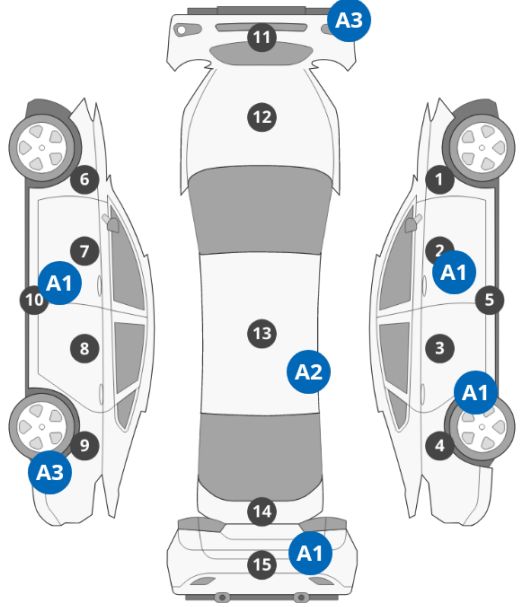
| <b>Remarks</b><br>(L) Front Seat - Grime - Medium / (R) Front Seat - Grime - Large / Rear Seat - Grime - Small / (L) Front Floor Mat - Grime - Medium / (R) Front Floor Mat - Missing - Yes / Mat Other - Missing - Yes / (L) Front Trim - Grime - Small / Ceiling - Grime - Minimal | <b>Remarks</b><br>(R) Front Door, Molding - Scratch - Minimal / (R) Rear Fender, Molding - Scratch - Minimal / (L) Rear Fender, Molding - Scratch - Medium / (L) Front Door, Molding - Scratch - Minimal / Front Bumper, Grille, Lamps - Scratch - Medium / Roof - Scratch - Small / Trunk Hood, Rear Gate - Scratch - Minimal |

| Inspector Notes |
|---|
| no warranty booklet, no jack, no tools, no spare tire, with LTO plate, crack on right tail light |
