## General Information

| Make | Toyota | Model | Vios |
| Registration No. | NGD6677 | Chassis No. | PA1B18F34L4109777 |

## Body / Panel Condition

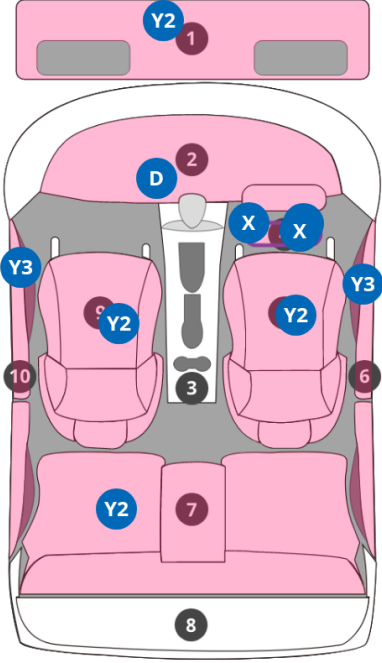
| Interior Evaluation : <b>B</b> | Exterior Evaluation : <b>C</b> |
|---|---|
| <p><b>Remarks</b></p> <p>Dashboard - Traces of Adhesive Tape - Yes / (L) Front Trim - Grime - Medium / Ceiling - Grime - Small / (R) Front Floor Mat - Missing - Yes / (L) Front Floor Mat - Missing - Yes / Mat Other - Missing - Yes / (L) Front Seat - Grime - Small / (R) Front Seat - Grime - Small / (R) Front Trim - Grime - Medium / Rear Seat - Grime - Small</p> | <p><b>Remarks</b></p> <p>(R) Step - Repair Traces - Yes / (L) Front Fender - Repair Traces - Yes / (L) Front Door - Repair Traces - Yes / (L) Step - Repair Traces - Yes / (R) Front Fender, Molding - Scratch - Small / (R) Front Door, Molding - Scratch &amp; Dent - Small / (R) Rear Door, Molding - Scratch &amp; Dent - Small / (R) Step, In-panel, Side Spoiler - Scratch - Minimal / Trunk Hood, Rear Gate - Scratch &amp; Dent - Small / Rear Bumper, Lamps, Panels - Scratch - Minimal / (L) Rear Fender, Molding - Scratch - Minimal / (L) Front Fender, Molding - Repair mark - Difference in Color / (L) Front Door, Molding - Scratch - Small / (L) Rear Door, Molding - Scratch - Small / Front Bumper, Grille, Lamps - Scratch - Medium / Bonnet, Headlight - Scratch - Minimal / Roof - Scratch - Small</p> |
