## General Information

| Make | Toyota | Model | Lite Ace |
| Registration No. | NHS5591 | Chassis No. | MHKU3FE10RK006876 |

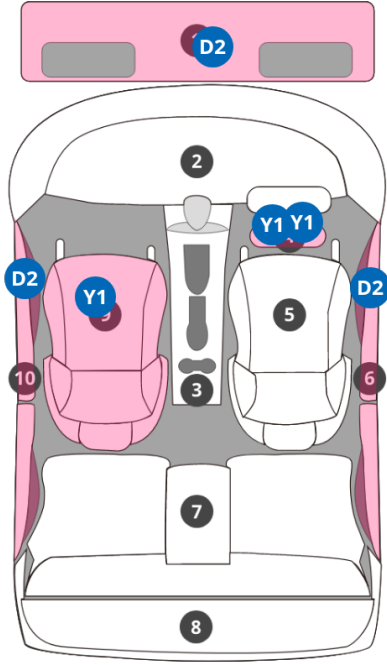
| Interior Evaluation : <b>A</b> | Exterior Evaluation : <b>E</b> |
| <b>Remarks</b><br>(L) Front Seat - Grime - Minimal / (L) Front Floor Mat - Grime - Minimal / (R) Front Floor Mat - Grime - Minimal / (L) Front Trim - Worked - Small / (R) Front Trim - Worked - Small / Ceiling - Crinkle - Small | <b>Remarks</b><br>(L) Front Fender, Molding - Scratch - Small / (R) Front Fender, Molding - Scratch - Small / Front Panel - Scratch - Small / Front Bumper, Grille, Lamps - Scratch - Medium / Front Windshield - Damaged - Large / Roof - Scratch & Dent - Small / Cab Back Panel - Scratch & Dent - Medium / Cargo Bed Floor - Scratch & Dent - Medium / Rear Gate - Scratch - Small / Rear Bumper, Lamps, Panels - Scratch - Medium / (R) Side Gate - Scratch & Dent - Medium / (L) Side Gate - Scratch & Dent - Medium / (L) Front Door, Molding - Scratch & Dent - Small / (R) Front Door, Molding - Scratch - Medium / (R) Step, In-panel, Side Spoiler - Scratch - Small / (L) Step, In-panel, Side Spoiler - Scratch - Small / (L) Center Panel - Scratch - Small / (R) Center Panel - Scratch - Small |

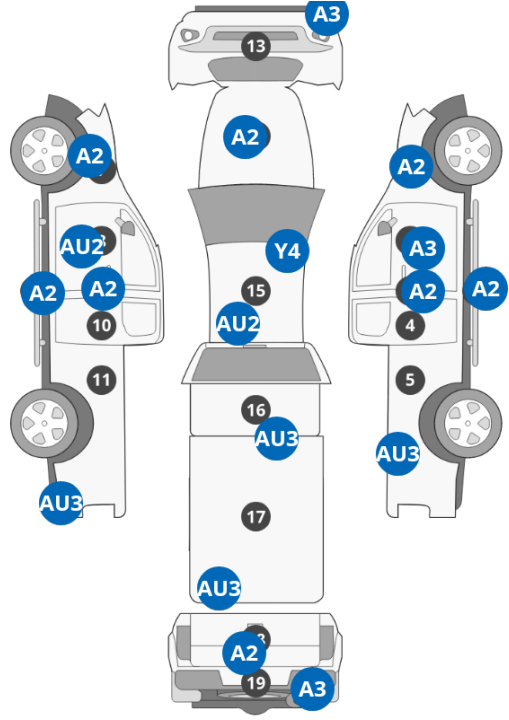
| Inspector Notes |
|---|
| with LTO plate, with spare tire, with warranty booklet, no tools and jack, no manual booklet, no reverse camera, scratches on taillight and headlight, issue on windshield, scratches and dent on exterior. |
