## General Information

| Make | Toyota | Model | Vios |
| Registration No. | NFJ6543 | Chassis No. | PA1B18F3XN4173308 |

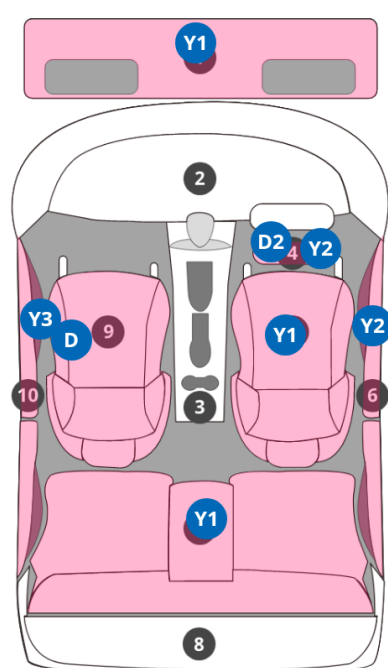
| <div> <div>Interior Evaluation :</div> <div>B</div> </div> | <div> <div>Exterior Evaluation :</div> <div>D</div> </div> |
| <div> <div>Remarks</div> <div>(R) Front Trim - Grime - Small / (R) Front Floor Mat - Grime - Small / (L) Front Trim - Grime - Medium / (L) Front Floor Mat - Worked - Small / (L) Front Seat - Worn - Yes / Rear Seat - Grime - Minimal / (R) Front Seat - Grime - Minimal / Ceiling - Grime - Minimal</div> </div> | <div> <div>Remarks</div> <div>(R) Rear Fender - Repair Traces - Yes / Roof - Repair Traces - Yes / (R) Rear Fender, Molding - Repair mark - Yes / (R) Front Fender, Molding - Dent - Small / (R) Step, In-panel, Side Spoiler - Scratch &amp; Dent - Small / (R) Front Door, Molding - Scratch - Minimal / (R) Rear Door, Molding - Scratch - Minimal / (R) Rear Fender, Molding - Scratch - Small / Trunk Hood, Rear Gate - Scratch &amp; Dent - Medium / Rear Bumper, Lamps, Panels - Scratch - Small / (L) Rear Fender, Molding - Scratch - Small / (L) Rear Door, Molding - Scratch - Minimal / (L) Mirror - Scratch - Minimal / (L) Front Door, Molding - Scratch - Small / (L) Front Fender, Molding - Scratch &amp; Dent - Medium / Bonnet, Headlight - Scratch &amp; Dent - Small / Front Bumper, Grille, Lamps - Scratch - Medium / Roof - Scratch - Minimal</div> </div> |
