## General Information

| Make | Toyota | Model | Vios |
| YOM | 2023 | Odo Meter Reading | 26,897 |
| Registration No. | NIJ9354 | Chassis No. | PA1B18F31P4204514 |

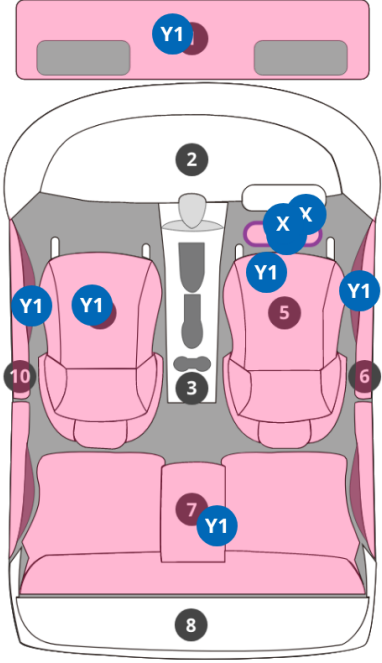
| Interior Evaluation : <b>B</b> | Exterior Evaluation : <b>C</b> |
|---|---|
| <b>Remarks</b><br>(L) Front Floor Mat - Missing - Yes / (R) Front Floor Mat - Missing - Yes / Mat Other - Missing - Yes / (R) Front Seat - Grime - Minimal / (L) Front Seat - Grime - Minimal / Rear Seat - Grime - Minimal / (L) Front Trim - Grime - Minimal / (R) Front Trim - Grime - Minimal / Ceiling - Grime - Minimal | <b>Remarks</b><br>(R) Front Fender - Repair Traces - Yes / Bonnet - Repair Traces - Yes / (L) Front Fender - Repair Traces - Yes / Trunk Hood, Rear Gate - Repair Traces - Yes / (R) Rear Door, Molding - Scratch & Dent - Small / (R) Front Door, Molding - Scratch & Dent - Small / (R) Step, In-panel, Side Spoiler - Scratch & Dent - Small / (R) Front Fender, Molding - Scratch & Dent - Small / (R) Rear Fender, Molding - Scratch - Small / Trunk Hood, Rear Gate - Scratch & Dent - Small / (L) Rear Fender, Molding - Scratch & Dent - Minimal / Rear Bumper, Lamps, Panels - Scratch - Small / (L) Step, In-panel, Side Spoiler - Scratch & Dent - Minimal / Roof - Scratch & Dent - Small / (L) Rear Door, Molding - Scratch & Dent - Small / Trunk Hood, Rear Gate - Repair mark - Yes / (L) Front Fender, Molding - Scratch & Dent - Small / Bonnet, Headlight - Scratch - Small / Front Bumper, Grille, Lamps - Scratch - Medium |

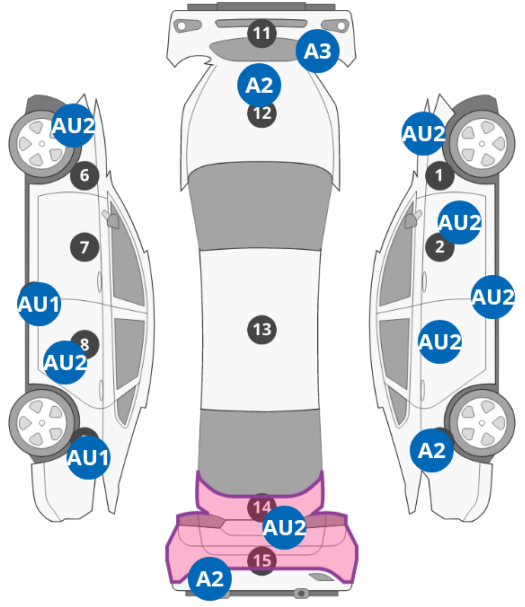
| Inspector Notes |
|---|
| with LTO plate, with spare tire, with jack and inc tools, with manual and warranty booklet, no reverse camera, no spare key, scratches on exterior, scratches on taillight and headlight. |
