## General Information

| Make | Toyota | Model | Vios |
| YOM | 2020 | Odo Meter Reading | 65,061 |
| Registration No. | NGN8465 | Chassis No. | PA1B1F39L4118801 |

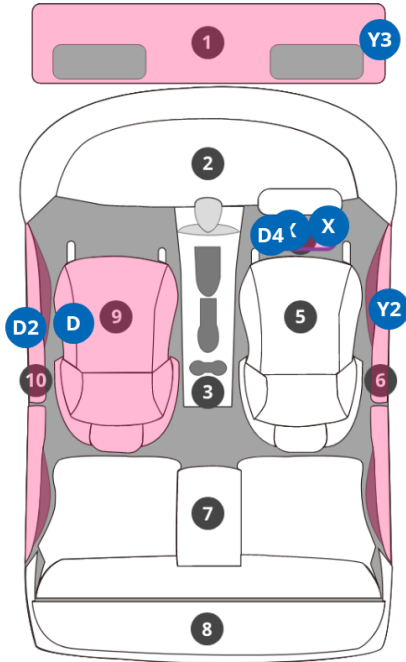
| Interior Evaluation : <b>C</b> | Exterior Evaluation : <b>D</b> |
|---|---|
| <p><b>Remarks</b></p> <p>(L) Front Floor Mat - Missing - Yes / (R) Front Floor Mat - Missing - Yes / Carpet - Worked - Large / (L) Front Trim - Worked - Small / (R) Front Trim - Grime - Small / (L) Front Seat - Worn - Yes / Ceiling - Grime - Medium</p> | <p><b>Remarks</b></p> <p>(R) Front Fender, Molding - Scratch - Minimal / (R) Mirror - Scratch - Small / (R) Front Door, Molding - Scratch - Small / (R) Rear Door, Molding - Scratch - Small / (R) Rear Fender, Molding - Scratch &amp; Dent - Small / Rear Bumper, Lamps, Panels - Scratch - Medium / Trunk Hood, Rear Gate - Scratch - Minimal / (L) Rear Fender, Molding - Scratch &amp; Dent - Medium / (L) Rear Door, Molding - Scratch &amp; Dent - Medium / (L) Step, In-panel, Side Spoiler - Scratch - Small / (L) Front Door, Molding - Scratch - Small / (L) Mirror - Scratch - Minimal / (L) Front Fender, Molding - Dent - Medium / Front Bumper, Grille, Lamps - Scratch - Small / Bonnet, Headlight - Scratch - Small / Roof - Scratch - Minimal / Member (Bolted) - Dent - Yes</p> |

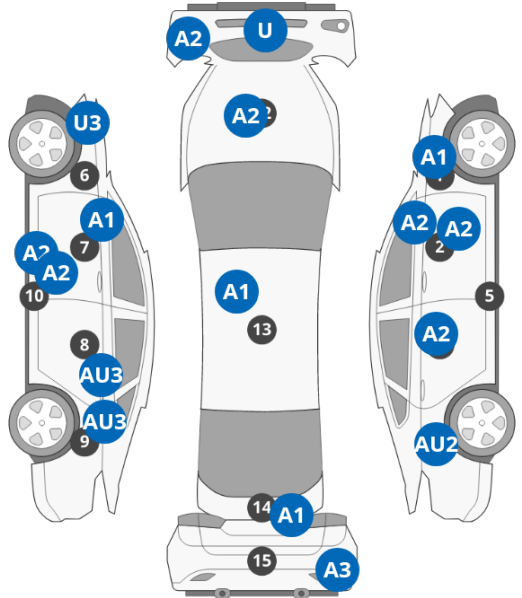
no warranty booklet, jack and tools, no spare tire, with LTO plate, scratches on tail light, possible flooding, worn tires, rear left tire issue, front cross member and radiator cover painted red
