## General Information

| Make | Toyota | Model | Lite Ace |
| Registration No. | GBC3027 | Chassis No. | MHKB3FE10PK003071 |

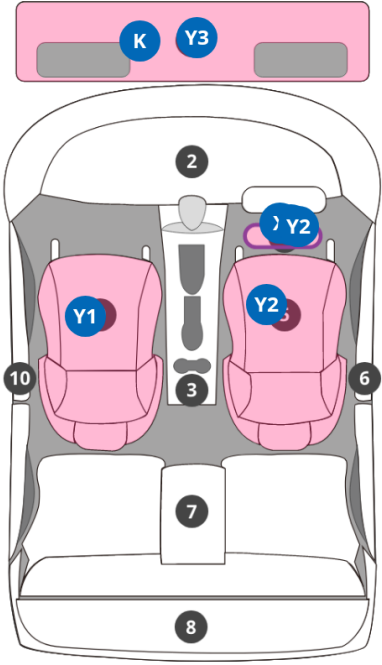
| Interior Evaluation : <b>B</b> | Exterior Evaluation : <b>E</b> |
| <b>Remarks</b><br>Overall Interior - Animal Hair - Yes / Ceiling - Grime - Medium / (L) Front Seat - Grime - Minimal / (R) Front Seat - Grime - Small / (R) Front Floor Mat - Missing - Yes / (L) Front Floor Mat - Missing - Yes / Mat Other - Grime - Small | <b>Remarks</b><br>(L) Mirror - Scratch - Minimal / Bonnet, Headlight - Scratch - Small / (R) Mirror - Scratch - Minimal / (R) Front Door, Molding - Scratch - Medium / (R) Rear Door, Molding - Scratch - Large / (R) Step, In-panel, Side Spoiler - Scratch - Minimal / (R) Rear Fender, Molding - Scratch - Large / Trunk Hood, Rear Gate - Scratch - Medium / Rear Bumper, Lamps, Panels - Scratch - Medium / (L) Rear Fender, Molding - Scratch - Medium / (L) Rear Door, Molding - Scratch - Medium / (L) Front Door, Molding - Scratch - Large |

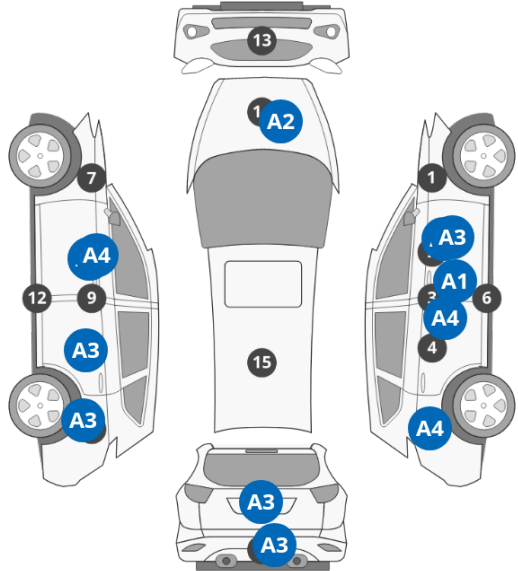
Left side rear light crack. With warranty booklet, tools, jack, seatcover, sparetire, LTO plate and 2keys.
