## General Information

| Make | Toyota | Model | Veloz |

## Body / Panel Condition

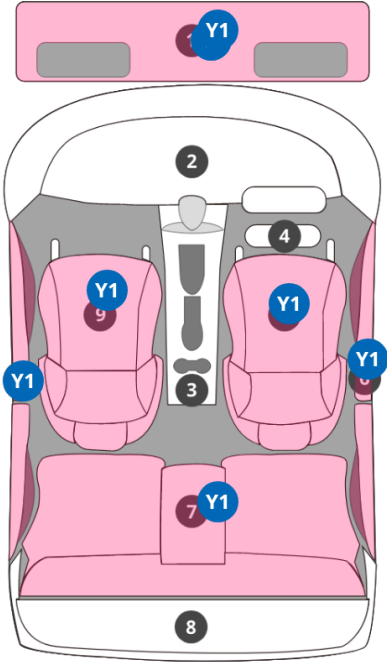
| Interior Evaluation : <b>B</b> | Exterior Evaluation : <b>E</b> |
|---|---|
| <p><b>Remarks</b><br/>(R) Front Seat - Grime - Minimal / Overall Interior - Animal Hair - Yes / Ceiling - Grime - Minimal / (L) Front Seat - Grime - Minimal / Rear Seat - Grime - Minimal / (R) Front Trim - Grime - Minimal / (L) Front Trim - Grime - Minimal</p> | <p><b>Remarks</b><br/>(L) Front Fender, Molding - Scratch - Small / (L) Mirror - Scratch - Minimal / Front Bumper, Grille, Lamps - Scratch - Small / Bonnet, Headlight - Scratch - Minimal / (R) Front Fender, Molding - Scratch - Small / (R) Mirror - Scratch - Small / (R) Front Door, Molding - Scratch - Medium / (R) Rear Door, Molding - Scratch - Large / (R) Step, In-panel, Side Spoiler - Scratch - Small / (R) Rear Fender, Molding - Scratch - Small / Rear Bumper, Lamps, Panels - Scratch - Medium / Trunk Hood, Rear Gate - Scratch - Minimal / (L) Rear Fender, Molding - Scratch &amp; Dent - Medium / (L) Rear Door, Molding - Scratch - Medium / (L) Step, In-panel, Side Spoiler - Scratch - Small / (L) Front Door, Molding - Scratch - Medium</p> |

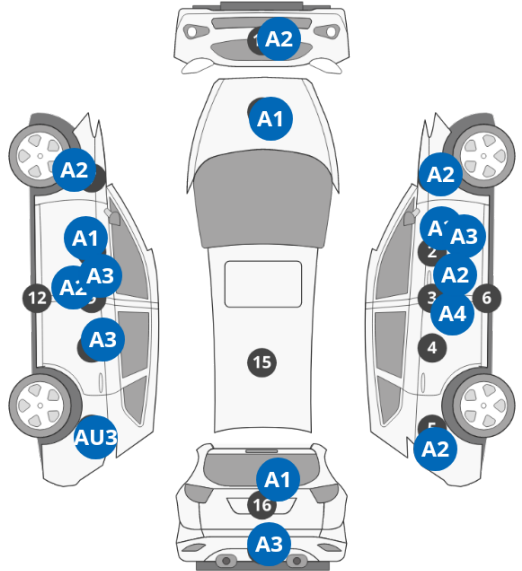
Visible hairline scratches. Engine top cover missing. Incomplete tools. Without warranty booklet. With sparetire, seatcover, jack, LTO PPlate and 1key.
