## General Information

| Make | Suzuki | Model | Carry |

## Body / Panel Condition

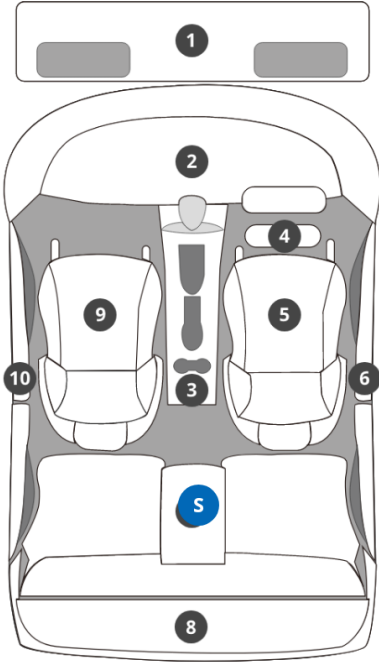
| Interior Evaluation : <b>B</b> | Exterior Evaluation : <b>D</b> |
| <b>Remarks</b><br>Overall Interior - Smell - Yes | <b>Remarks</b><br>(L) Front Fender, Molding - Dent - Small / Front Bumper, Grille, Lamps - Dent - Medium / (R) Side Gate - Scratch & Dent - Large / Rear Bumper, Lamps, Panels - Scratch & Dent - Large / (L) Side Gate - Dent - Medium / Cargo Bed Floor - Scratch - Large / Roof - Scratch & Dent - Large |
