## General Information

| Make | Toyota | Model | Wigo |
| Registration No. | FAN6437 | Chassis No. | MHKA4DF5FNJ072626 |

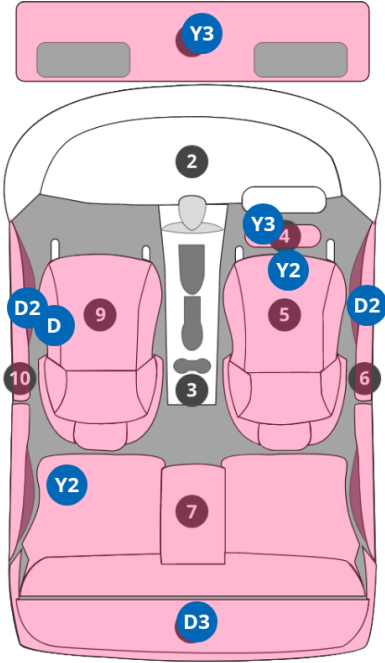
| Interior Evaluation : <span style="color: red;">C</span> | Exterior Evaluation : <span style="color: red;">E</span> |
| <b>Remarks</b><br>Ceiling - Grime - Medium / (L) Front Floor Mat - Grime - Medium / (L) Front Seat - Worn - Yes / (R) Front Seat - Grime - Small / (L) Front Trim - Worked - Small / (R) Front Trim - Worked - Small / Rear Seat - Grime - Small / Trunk Room - Loose, Deformed - Medium | <b>Remarks</b><br>(R) Rear Door, Molding - Scratch - Small / (R) Mirror - Scratch - Minimal / (R) Front Door, Molding - Scratch - Medium / (R) Rear Fender, Molding - Scratch - Small / Rear Bumper, Lamps, Panels - Crack, Gap - Medium / Trunk Hood, Rear Gate - Scratch - Small / (L) Rear Fender, Molding - Scratch - Small / (L) Rear Door, Molding - Scratch - Small / (L) Step, In-panel, Side Spoiler - Scratch - Medium / (L) Front Fender, Molding - Dent - Medium / (L) Front Door, Molding - Scratch - Small / (L) Mirror - Scratch - Small / (R) Front Fender, Molding - Scratch & Dent - Small / Front Bumper, Grille, Lamps - Scratch - Small / Bonnet, Headlight - Scratch - Minimal / Roof Spoiler, Molding - Scratch - Small |
