## General Information

| Make | Toyota | Model | Rush |
| Registration No. | NGT1732 | Chassis No. | MHKE8FF3PLK030722 |

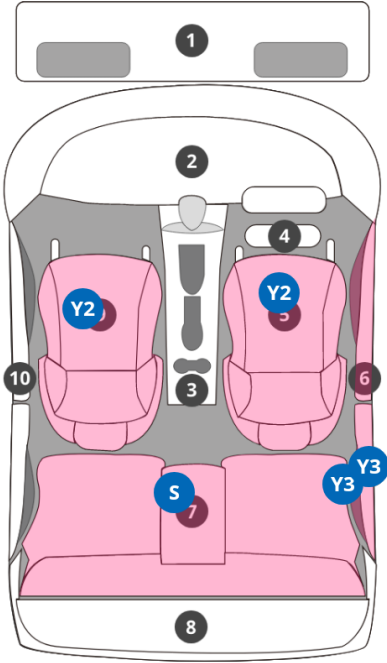
| Interior Evaluation : <span style="color: red;">C</span> | Exterior Evaluation : <span style="color: red;">D</span> |
| <b>Remarks</b><br>Overall Interior - Smell - Yes / Overall Interior - Worn as per age - Yes / (R) Front Seat - Grime - Small / (L) Front Seat - Grime - Small / Rear Seat - Grime - Medium / (R) Rear Trim - Grime - Medium | <b>Remarks</b><br>Bonnet - Repair Traces - Yes / (L) Front Fender - Repair Traces - Yes / Bonnet, Headlight - Scratch & Dent - Medium / Front Bumper, Grille, Lamps - Scratch & Dent - Large / (L) Rear Fender, Molding - Scratch & Dent - Small / Trunk Hood, Rear Gate - Scratch & Dent - Medium / (R) Rear Door, Molding - Scratch & Dent - Large / (R) Step, In-panel, Side Spoiler - Scratch - Medium / (R) Front Fender, Molding - Scratch & Dent - Medium / (L) Rear Door, Molding - Scratch & Dent - Small / (L) Front Door, Molding - Dent - Small / (R) Front Door, Molding - Scratch & Dent - Small / (R) Rear Fender, Molding - Dent - Minimal |
