## General Information

| Make | Toyota | Model | Vios |
| Registration No. | FAP8801 | Chassis No. | PA1B18F3584194387 |

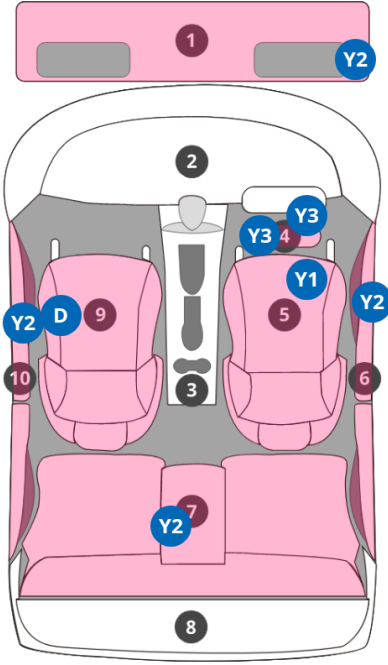
| Interior Evaluation : <span style="color: red;">C</span> | Exterior Evaluation : <span style="color: red;">E</span> |
| <p><b>Remarks</b><br/>(L) Front Floor Mat - Grime - Medium / (L) Front Seat - Worn - Yes / (R) Front Floor Mat - Grime - Medium / Rear Seat - Grime - Small / (R) Front Seat - Grime - Minimal / Ceiling - Grime - Small / (L) Front Trim - Grime - Small / (R) Front Trim - Grime - Small</p> | <p><b>Remarks</b><br/>(R) Mirror - Scratch - Small / (R) Front Door, Molding - Scratch &amp; Dent - Large / (R) Front Fender, Molding - Scratch - Small / (R) Rear Door, Molding - Scratch - Medium / (R) Rear Fender, Molding - Scratch - Small / Trunk Hood, Rear Gate - Modified - Medium / Rear Bumper, Lamps, Panels - Scratch - Small / Trunk Hood, Rear Gate - Scratch - Medium / (L) Rear Fender, Molding - Scratch - Small / (L) Rear Door, Molding - Scratch - Small / (L) Front Door, Molding - Scratch - Medium / (L) Mirror - Scratch - Minimal / (L) Front Fender, Molding - Scratch - Small / Front Bumper, Grille, Lamps - Scratch - Medium / Bonnet, Headlight - Scratch - Small / Roof - Scratch - Minimal</p> |

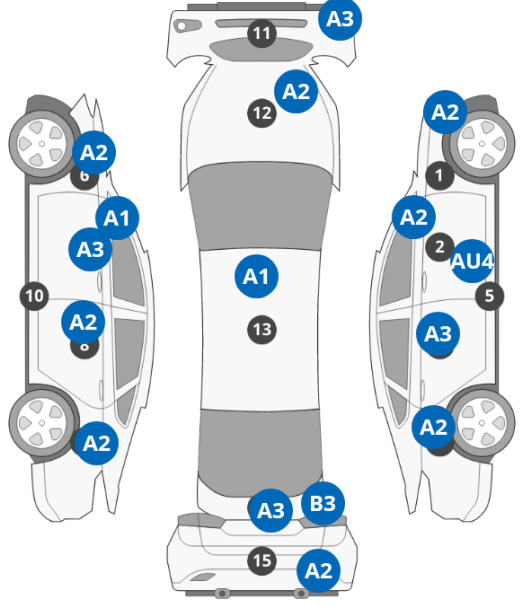
| Inspector Notes |
|---|
| with warranty, no jack, incomplete tools, with spare tire, with LTO plate, scratches on tail light |
