## General Information

| Make | Toyota | Model | Avanza |
| Registration No. | FBB1132 | Chassis No. | MHFAA1BY6S0049723 |

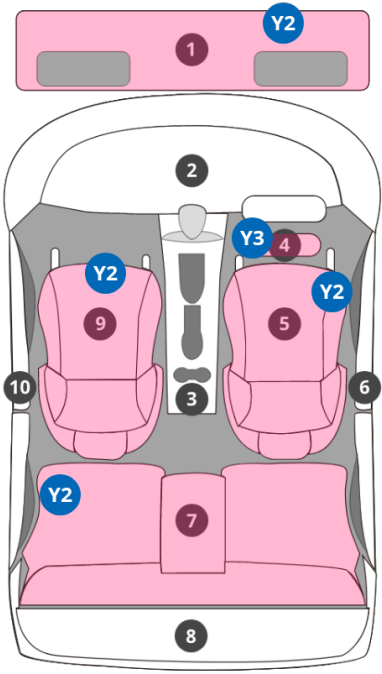
| Interior Evaluation : <b>B</b> | Exterior Evaluation : <b>D</b> |
|---|---|
| <b>Remarks</b><br>(L) Front Floor Mat - Grime - Medium / (L) Front Seat - Grime - Small / (R) Front Seat - Grime - Small / Ceiling - Grime - Small / Rear Seat - Grime - Small | <b>Remarks</b><br>(R) Front Fender, Molding - Scratch - Minimal / (R) Mirror - Scratch - Minimal / (R) Step, In-panel, Side Spoiler - Scratch & Dent - Large / (R) Front Door, Molding - Scratch - Large / (R) Rear Door, Molding - Scratch - Small / Rear Bumper, Lamps, Panels - Scratch - Small / Trunk Hood, Rear Gate - Scratch - Small / (R) Rear Fender, Molding - Scratch & Dent - Small / (L) Rear Fender, Molding - Scratch - Small / (L) Rear Door, Molding - Scratch & Dent - Small / (L) Mirror - Scratch - Minimal / (L) Front Door, Molding - Scratch - Small / (L) Front Fender, Molding - Scratch - Minimal / Front Bumper, Grille, Lamps - Scratch - Small / Bonnet, Headlight - Scratch - Minimal / Roof - Scratch - Minimal |

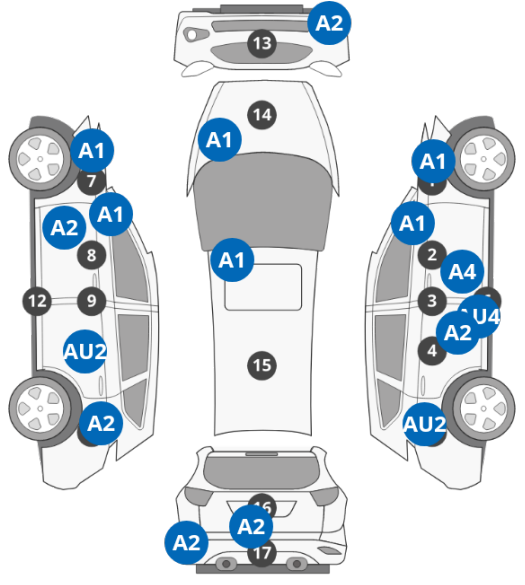
| Inspector Notes |
|---|
| with warranty booklet, no jack, incomplete tools, with spare tire, with LTO plate, scratches on tail light |
