## General Information

| Make | Toyota | Model | Vios |

## Body / Panel Condition

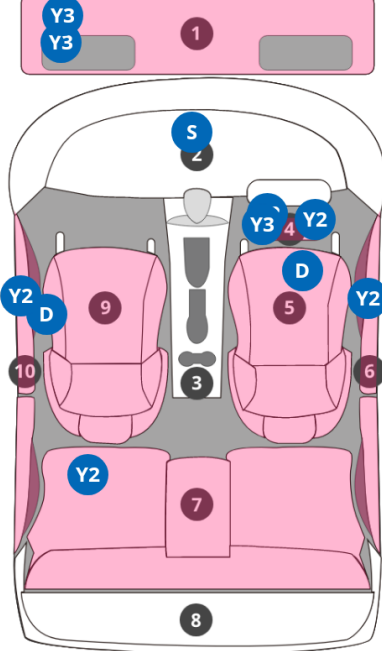
| Interior Evaluation : <b>C</b> | Exterior Evaluation : <b>E</b> |
| <p><b>Remarks</b></p> <p>(L) Front Floor Mat - Worked - Small / (L) Front Floor Mat - Grime - Medium / (L) Front Seat - Worn - Yes / Overall Interior - Smell - Yes / (R) Front Floor Mat - Grime - Small / (R) Front Trim - Grime - Small / (L) Front Trim - Grime - Small / (R) Front Seat - Worn - Yes / Rear Seat - Grime - Small / Sunvisor, Sunglass Holder - Grime - Medium / Ceiling - Grime - Medium</p> | <p><b>Remarks</b></p> <p>(R) Mirror - Scratch - Minimal / (R) Front Fender, Molding - Scratch - Minimal / (R) Step, In-panel, Side Spoiler - Scratch &amp; Dent - Large / (R) Rear Door, Molding - Scratch &amp; Dent - Large / (R) Front Door, Molding - Scratch &amp; Dent - Small / (R) Rear Fender, Molding - Scratch &amp; Dent - Medium / Rear Bumper, Lamps, Panels - Scratch - Medium / Trunk Hood, Rear Gate - Scratch &amp; Dent - Small / (L) Rear Fender, Molding - Scratch - Medium / (L) Front Door, Molding - Scratch &amp; Dent - Large / (L) Rear Door, Molding - Scratch - Large / (L) Mirror - Scratch - Small / (L) Front Fender, Molding - Scratch - Medium / Front Bumper, Grille, Lamps - Scratch &amp; Dent - Medium / Bonnet, Headlight - Scratch &amp; Dent - Medium / Roof - Scratch - Medium</p> |

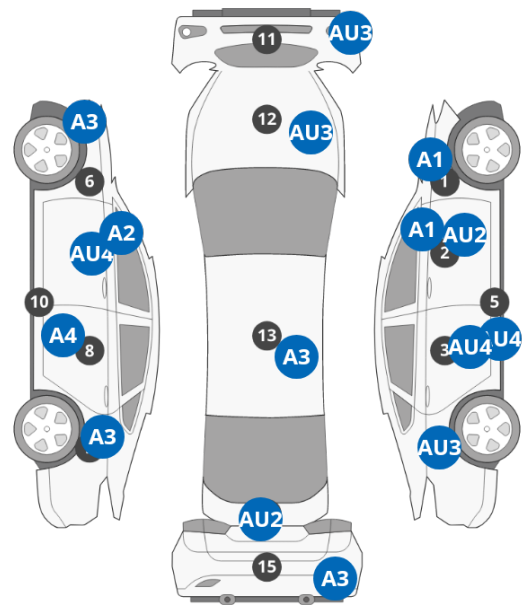
| Inspector Notes |
|---|
| no warranty booklet and tools, with jack, with spare tire, with LTO plate, scratches on tail light, possible flooding, most of the panel touched up marks |
