## General Information

| Make | Toyota | Model | Wigo |
| YOM | 2022 | Odo Meter Reading | 54,342 |

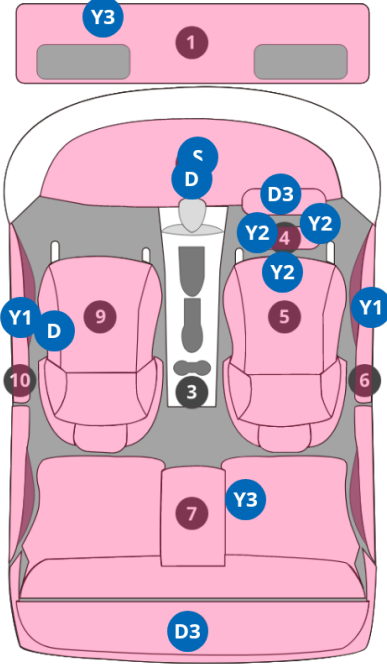
| Interior Evaluation : <b>C</b> | Exterior Evaluation : <b>E</b> |
|---|---|
| <p><b>a</b> : Cut, Fray <b>d</b> : Loose, Deformed <b>k</b> : Animal Hair <b>s</b> : Smell <b>t</b> : Cigarette Burns <b>x</b> : Defective <b>y</b> : Stain</p> | <p><b>A</b> : Scratch <b>AU</b> : Scratch &amp; Dent <b>B</b> : Modified <b>C</b> : Corrosion <b>G</b> : Stone chip <b>P</b> : Faded <b>S</b> : Rust <b>SC</b> : Rust &amp; Corrosion <b>U</b> : Dent <b>X</b> : Defective <b>Y</b> : Crack, Gap</p> |
| <p><b>Remarks</b></p> <p>Rear Seat - Grime - Medium / Overall Interior - Worn as per age - Yes / Overall Interior - Smell - Yes / Glove Box - Loose, Deformed - Medium / Dashboard - Traces of Adhesive Tape - Yes / (L) Front Trim - Grime - Minimal / (R) Front Trim - Grime - Minimal / (L) Front Floor Mat - Grime - Small / (R) Front Floor Mat - Grime - Small / (R) Front Seat - Grime - Small / Trunk Room - Loose, Deformed - Medium / Ceiling - Grime - Medium / (L) Front Seat - Worn - Yes</p> | <p><b>Remarks</b></p> <p>(R) Front Fender - Repair Traces - Yes / (R) Front Fender, Molding - Scratch - Medium / (R) Mirror - Scratch - Minimal / (R) Front Door, Molding - Scratch &amp; Dent - Medium / (R) Step, In-panel, Side Spoiler - Scratch - Medium / (R) Rear Door, Molding - Scratch &amp; Dent - Large / (R) Rear Fender, Molding - Scratch &amp; Dent - Medium / Rear Bumper, Lamps, Panels - Crack, Gap - Medium / Trunk Hood, Rear Gate - Scratch - Small / Bonnet, Headlight - Scratch &amp; Dent - Small / (L) Rear Fender, Molding - Scratch &amp; Dent - Medium / (L) Step, In-panel, Side Spoiler - Scratch - Medium / (L) Rear Door, Molding - Scratch - Small / (L) Front Door, Molding - Scratch &amp; Dent - Medium / (L) Mirror - Scratch - Small / (L) Front Fender, Molding - Scratch - Medium / Front Bumper, Grille, Lamps - Scratch &amp; Dent - Medium / Roof - Scratch - Medium</p> |
