## General Information

| Make | Toyota | Model | Vios |

## Body / Panel Condition

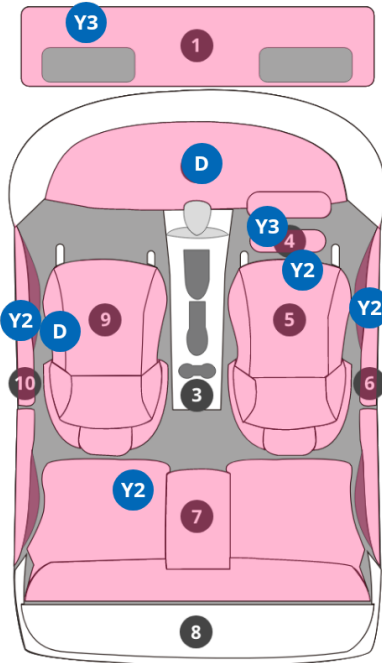
| Interior Evaluation : <b>C</b> | Exterior Evaluation : <b>E</b> |
|---|---|
| <p><b>Remarks</b><br/>(L) Front Floor Mat - Grime - Medium / (L) Front Seat - Worn - Yes / (R) Front Seat - Grime - Small / (R) Front Trim - Grime - Small / (L) Front Trim - Grime - Small / Ceiling - Grime - Medium / Dashboard - Traces of Adhesive Tape - Yes / Rear Seat - Grime - Small</p> | <p><b>Remarks</b><br/>Member (Bolted) - Dent - Yes / (R) Mirror - Scratch - Small / (R) Front Fender, Molding - Scratch - Small / (R) Rear Door, Molding - Scratch &amp; Dent - Small / (R) Front Door, Molding - Scratch - Medium / (R) Rear Fender, Molding - Scratch - Small / Rear Bumper, Lamps, Panels - Scratch - Small / Trunk Hood, Rear Gate - Scratch - Medium / (L) Rear Fender, Molding - Scratch - Medium / (L) Rear Door, Molding - Scratch - Medium / (L) Front Door, Molding - Scratch - Medium / (L) Mirror - Scratch - Minimal / (L) Front Fender, Molding - Scratch - Medium / Front Bumper, Grille, Lamps - Scratch - Medium / Bonnet, Headlight - Scratch - Small / Roof - Scratch - Small</p> |
