## General Information

| Make | Toyota | Model | Avanza |

## Body / Panel Condition

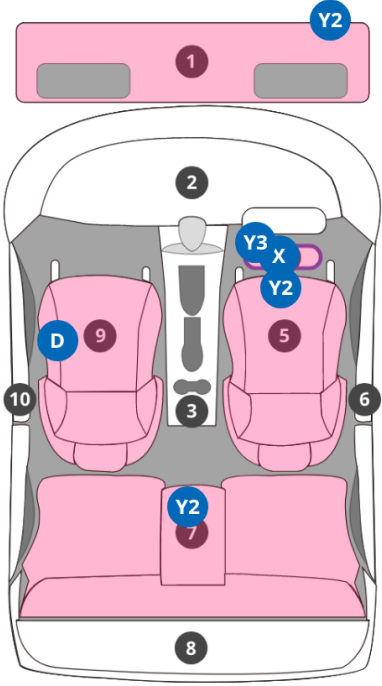
| Interior Evaluation : <b>B</b> | Exterior Evaluation : <b>E</b> |
| <b>Remarks</b><br>Mat Other - Missing - Yes / (L) Front Floor Mat - Grime - Medium / (L) Front Seat - Worn - Yes / (R) Front Seat - Grime - Small / Ceiling - Grime - Small / Rear Seat - Grime - Small | <b>Remarks</b><br>(R) Mirror - Scratch - Small / (R) Rear Door, Molding - Scratch - Medium / (R) Front Fender, Molding - Scratch & Dent - Medium / (R) Front Door, Molding - Scratch - Small / (R) Step, In-panel, Side Spoiler - Scratch & Dent - Large / (R) Rear Fender, Molding - Scratch - Minimal / Rear Bumper, Lamps, Panels - Scratch - Medium / Trunk Hood, Rear Gate - Scratch - Minimal / (L) Rear Fender, Molding - Scratch - Medium / (L) Rear Door, Molding - Scratch & Dent - Medium / (L) Front Door, Molding - Scratch - Small / (L) Front Fender, Molding - Scratch - Small / (L) Mirror - Scratch - Small / Front Bumper, Grille, Lamps - Scratch - Medium / Bonnet, Headlight - Scratch - Small / Roof - Scratch - Medium |

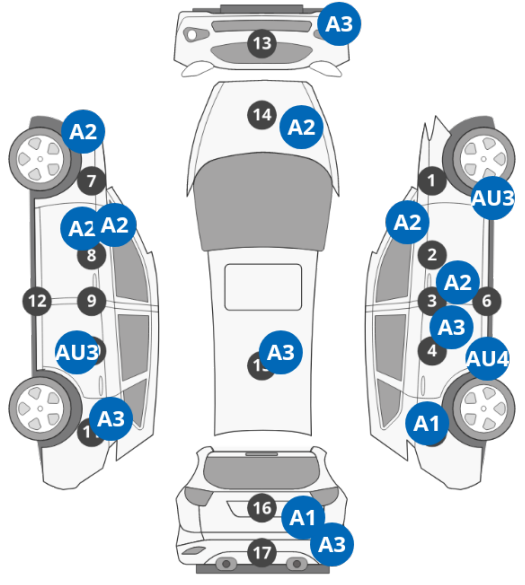
with warranty booklet and jack, incomplete tools, with spare tire, with LTO plate, scratches on tail light
