## General Information

| Make | Toyota | Model | Vios |

## Body / Panel Condition

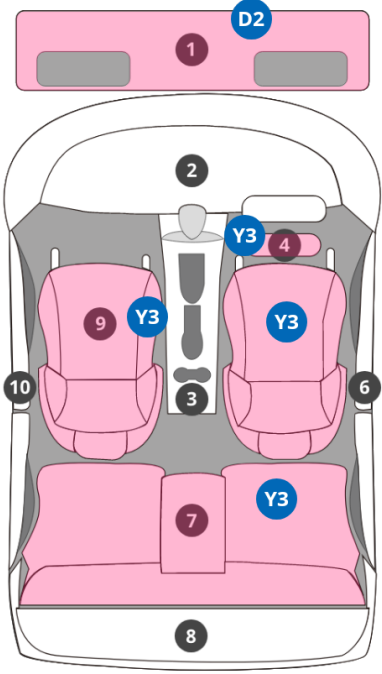
| Interior Evaluation : <b>B</b> | Exterior Evaluation : <b>C</b> |
|---|---|
| <p><b>Remarks</b><br/>Ceiling - Crinkle - Small / (R) Front Seat - Grime - Medium / Rear Seat - Grime - Medium / (L) Front Floor Mat - Grime - Medium / (L) Front Seat - Grime - Medium</p> | <p><b>Remarks</b><br/>(L) Rear Fender - Repair Traces - Yes / (R) Mirror - Scratch - Minimal / Front Bumper, Grille, Lamps - Scratch &amp; Dent - Small / (L) Rear Fender, Molding - Scratch - Medium / Rear Bumper, Lamps, Panels - Scratch - Large / (R) Rear Door, Molding - Scratch &amp; Dent - Minimal / (R) Rear Fender, Molding - Scratch - Small</p> |
