## General Information

| Make | Toyota | Model | Raize |
| Registration No. | FAN8856 | Chassis No. | MHKAB1BA6NJ033523 |

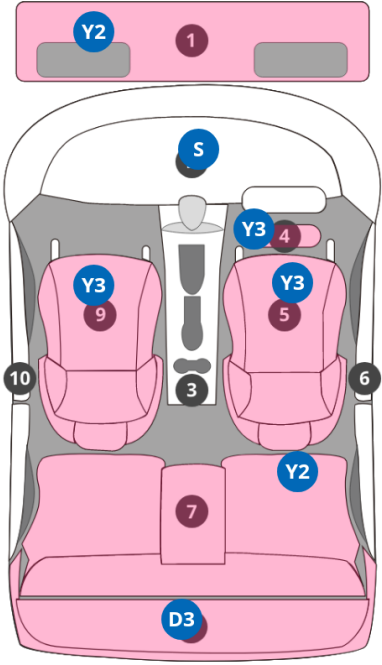
| Interior Evaluation : <b>C</b> | Exterior Evaluation : <b>E</b> |
| <p><b>Remarks</b></p> <p>Trunk Room - Loose, Deformed - Medium / Overall Interior - Smell - Yes / (L) Front Floor Mat - Grime - Medium / (L) Front Seat - Grime - Medium / (R) Front Seat - Grime - Medium / Ceiling - Grime - Small / Rear Seat - Grime - Small</p> | <p><b>Remarks</b></p> <p>(R) Front Door - Repair Traces - Yes / (R) Rear Door - Repair Traces - Yes / (R) Front Fender, Molding - Crack, Gap - Large / (R) Front Door, Molding - Scratch - Medium / (R) Rear Door, Molding - Scratch &amp; Dent - Medium / (R) Rear Fender, Molding - Scratch - Minimal / Rear Bumper, Lamps, Panels - Repair mark - Yes / Rear Bumper, Lamps, Panels - Scratch - Small / Trunk Hood, Rear Gate - Scratch - Small / (L) Rear Fender, Molding - Scratch - Small / (L) Step, In-panel, Side Spoiler - Scratch - Small / (L) Front Door, Molding - Scratch - Small / (L) Rear Door, Molding - Scratch - Small / (L) Mirror - Scratch - Minimal / (L) Front Fender, Molding - Scratch - Small / Front Bumper, Grille, Lamps - Scratch - Medium / Bonnet, Headlight - Scratch - Small / Roof - Scratch - Minimal / Front Windshield - Damaged - Large / (R) Mirror - Scratch - Small</p> |

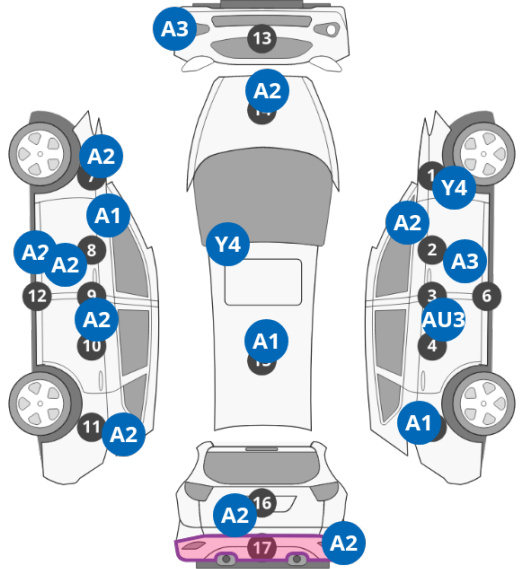
no warranty booklet and tools, with jack, no spare tire, with LTO plate, scratches on headlight and tail light, fog lamp issue, rough idling, possible flooding, rear right wheel issue, cracked front windshield,
