## General Information

| Make | Toyota | Model | Fortuner |
| YOM | 2023 | Mileage | 21,000 |
| Registration No. | NFP9061 | Chassis No. | MHFAA8GS8N0786763 |

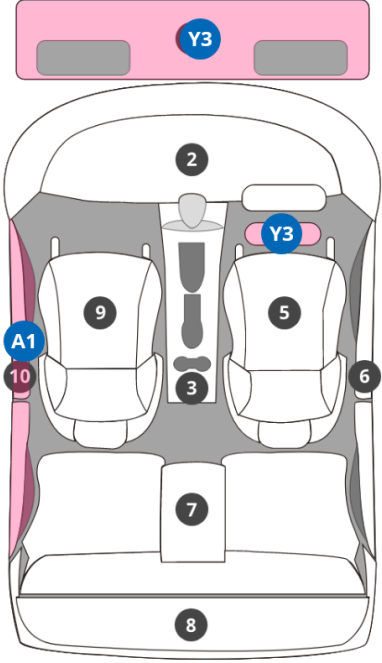
| <b>Remarks</b><br>(L) Front Floor Mat - Grime - Medium / (L) Front Trim - Cut, Crack - Minimal / Ceiling - Grime - Medium | <b>Remarks</b><br>(R) Front Fender, Molding - Scratch & Dent - Large / (R) Front Door, Molding - Scratch - Small / Rear Bumper, Lamps, Panels - Scratch - Minimal / Trunk Hood, Rear Gate - Scratch - Small / Front Bumper, Grille, Lamps - Repair mark - Yes / Front Bumper, Grille, Lamps - Scratch - Small / Bonnet, Headlight - Scratch - Small / (L) Front Fender, Molding - Scratch - Minimal / (L) Mirror - Scratch - Minimal |
