## General Information

| Make | Toyota | Model | Vios |
| Registration No. | DBJ9644 | Chassis No. | PA1B18F35P4227827 |

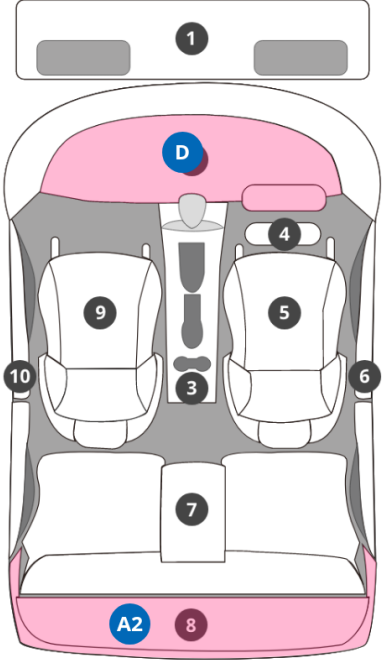
| <b>Interior Evaluation :</b> <span style="color: red; font-weight: bold;">A</span> | <b>Exterior Evaluation :</b> <span style="color: red; font-weight: bold;">C</span> |
| <b>Remarks</b><br>Dashboard - Traces of Adhesive Tape - Yes / Trunk Room - Worn, Scratch, Cut, Crack - Small | <b>Remarks</b><br>Roof - Dent - Minimal / Rear Bumper, Lamps, Panels - Dent - Minimal / (L) Front Fender, Molding - Scratch - Medium / Front Bumper, Grille, Lamps - Crack, Gap - Large / (R) Rear Door, Molding - Scratch - Minimal |
