## General Information

| Make | Toyota | Model | Vios |
| Registration No. | EAE5510 | Chassis No. | PA1B18F35M4148542 |

## Body / Panel Condition

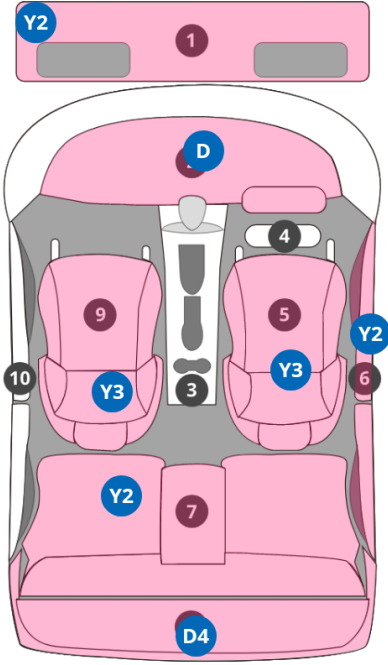
| Interior Evaluation : <span style="color: red;">C</span> | Exterior Evaluation : <span style="color: red;">C</span> |
| <p><b>Remarks</b></p> <p>(R) Front Seat - Grime - Medium / (R) Front Trim - Grime - Small / (L) Front Seat - Grime - Medium / Rear Seat - Grime - Small / Dashboard - Traces of Adhesive Tape - Yes / Ceiling - Grime - Small / Trunk Room - Worked - Large</p> | <p><b>Remarks</b></p> <p>(R) Front Fender, Molding - Scratch &amp; Dent - Small / (R) Rear Fender, Molding - Scratch &amp; Dent - Minimal / (R) Rear Door, Molding - Scratch - Large / Rear Bumper, Lamps, Panels - Scratch - Medium / (L) Rear Fender, Molding - Scratch - Minimal / (L) Rear Door, Molding - Scratch - Small / (L) Step, In-panel, Side Spoiler - Dent - Small / Front Bumper, Grille, Lamps - Scratch - Medium / (L) Front Door, Molding - Scratch &amp; Dent - Minimal / Roof - Scratch - Medium</p> |
