## General Information

| Make | Toyota | Model | Avanza |
| YOM | 2023 | Mileage | 67,459 |
| Registration No. | NHB4907 | Chassis No. | MHFAA1BY6N0006780 |

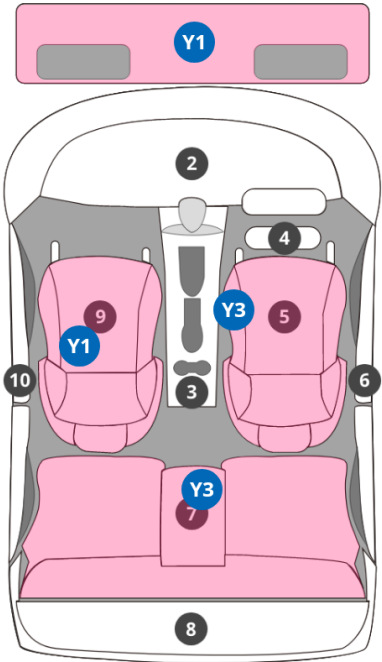
| <b>Interior Evaluation :</b> <span style="color: red; font-weight: bold;">B</span> | <b>Exterior Evaluation :</b> <span style="color: red; font-weight: bold;">C</span> |
| <p><b>Remarks</b><br/>Ceiling - Grime - Minimal / (R) Front Seat - Grime - Medium / Rear Seat - Grime - Medium / (L) Front Seat - Grime - Minimal</p> | <p><b>Remarks</b><br/>Bonnet - Repair Traces - Yes / (L) Front Fender - Repair Traces - Yes / (R) Rear Fender, Molding - Dent - Minimal / Bonnet, Headlight - Scratch &amp; Dent - Medium / (R) Front Door, Molding - Scratch &amp; Dent - Medium / Rear Bumper, Lamps, Panels - Scratch - Medium / (L) Front Door, Molding - Scratch - Small / (L) Mirror - Scratch - Small / Front Bumper, Grille, Lamps - Scratch &amp; Dent - Large / (R) Mirror - Scratch - Small / Roof - Dent - Small / (R) Rear Door, Molding - Dent - Small / (L) Rear Door, Molding - Scratch - Minimal</p> |

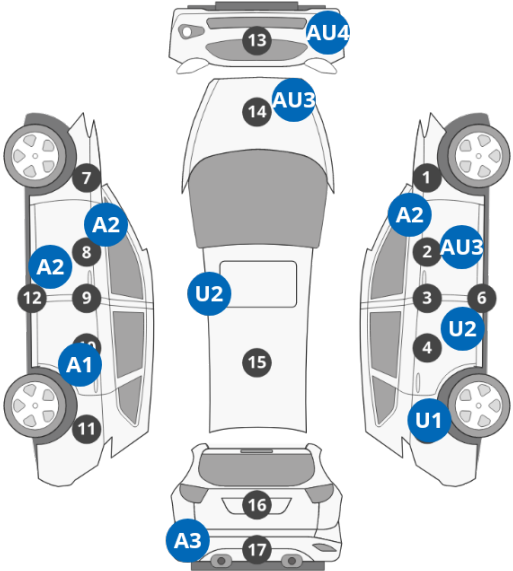
| Inspector Notes |
|---|
| <p>no right reverse light, Gap at the front bumper. with warranty booklet, spare tire and jack. no tools. with LTO plate.</p> |
