## General Information

| Make | Toyota | Model | Vios |
| YOM | 2023 | Mileage | 10,502 |
| Registration No. | NIH4329 | Chassis No. | PA1B18F31N4199375 |

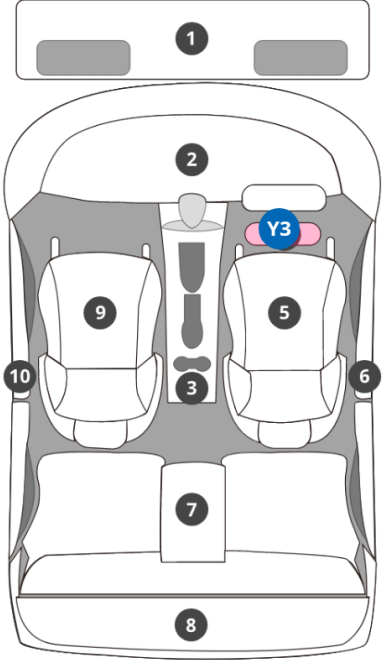
| Interior Evaluation : <b>B</b> | Exterior Evaluation : <b>B</b> |
| <b>Remarks</b><br>Mat Other - Grime - Medium | <b>Remarks</b><br>(R) Rear Door, Molding - Scratch - Small / (R) Rear Fender, Molding - Scratch - Minimal / Rear Bumper, Lamps, Panels - Scratch - Medium / (L) Rear Fender, Molding - Scratch & Dent - Minimal / (L) Mirror - Scratch - Minimal / (L) Front Fender, Molding - Scratch - Small / Front Bumper, Grille, Lamps - Scratch - Medium |
