## General Information

| Make | Toyota | Model | Vios |

## Body / Panel Condition

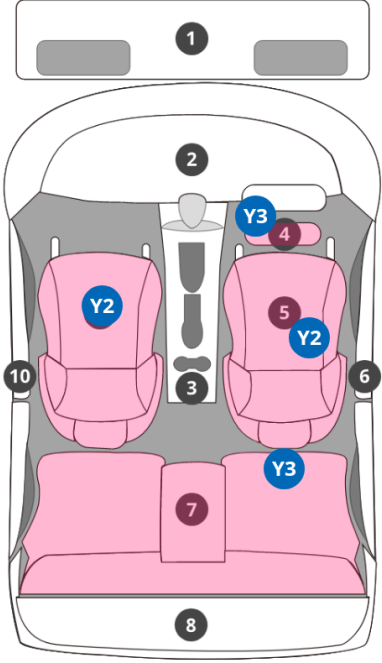
| <b>Interior Evaluation :</b> <b>B</b> | <b>Exterior Evaluation :</b> <b>B</b> |
| <b>Remarks</b><br>(R) Front Seat - Grime - Small / Rear Seat - Grime - Medium / (L) Front Floor Mat - Grime - Medium / (L) Front Seat - Grime - Small | <b>Remarks</b><br>(R) Mirror - Scratch - Small / (R) Front Door, Molding - Scratch & Dent - Small / (R) Rear Door, Molding - Scratch - Small / (R) Rear Fender, Molding - Scratch - Small / (L) Mirror - Scratch - Minimal |
