## General Information

| Make | Toyota | Model | Vios |
| YOM | 2023 | Mileage | 47,530 |

## Body / Panel Condition

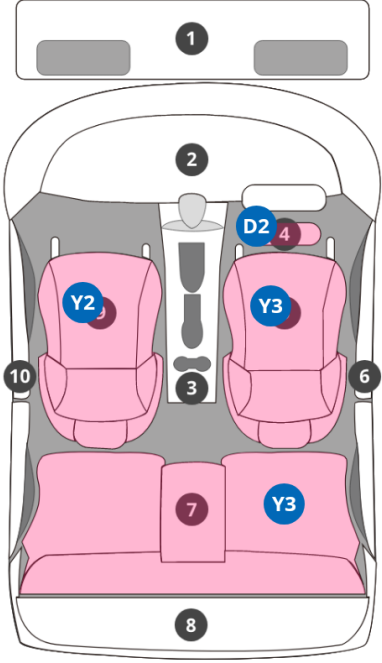
| Interior Evaluation : <b>B</b> | Exterior Evaluation : <b>C</b> |
| <b>Remarks</b><br>(R) Front Seat - Grime - Medium / Rear Seat - Grime - Medium / (L) Front Floor Mat - Worked - Small / (L) Front Seat - Grime - Small | <b>Remarks</b><br>(R) Front Fender - Repair Traces - Yes / (L) Rear Fender, Molding - Scratch & Dent - Medium / Front Bumper, Grille, Lamps - Scratch - Medium / (R) Rear Door, Molding - Dent - Small / Bonnet, Headlight - Scratch & Dent - Minimal / (R) Rear Fender, Molding - Scratch - Small / Rear Bumper, Lamps, Panels - Scratch & Dent - Small / (L) Rear Door, Molding - Scratch & Dent - Medium / (L) Mirror - Scratch - Small |
