## General Information

| Make | Toyota | Model | Wigo |
| YOM | 2025 | Odo Meter Reading | 10,603 |
| Registration No. | GBK5162 | Chassis No. | MHKAA1BC6SJ040486 |

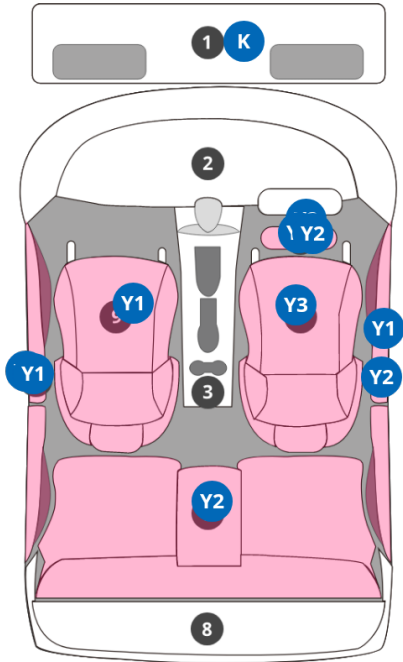
| Interior Evaluation : <b>B</b> | Exterior Evaluation : <b>D</b> |
| <p><b>Remarks</b></p> <p>Mat Other - Grime - Small / Overall Interior - Animal Hair - Yes / (R) Rear Trim - Grime - Small / Rear Seat - Grime - Small / (R) Front Trim - Grime - Minimal / (R) Front Floor Mat - Grime - Small / (R) Front Seat - Grime - Medium / (L) Rear Trim - Grime - Minimal / (L) Front Trim - Grime - Minimal / (L) Front Seat - Grime - Minimal / (L) Front Floor Mat - Grime - Small</p> | <p><b>Remarks</b></p> <p>(L) Front Fender, Molding - Scratch - Minimal / Front Bumper, Grille, Lamps - Scratch - Large / Bonnet, Headlight - Scratch - Minimal / (R) Front Fender, Molding - Scratch - Small / (R) Front Door, Molding - Scratch - Medium / (R) Rear Door, Molding - Scratch - Medium / (R) Step, In-panel, Side Spoiler - Scratch - Small / (R) Rear Fender, Molding - Scratch - Small / Trunk Hood, Rear Gate - Scratch - Minimal / Rear Bumper, Lamps, Panels - Scratch - Minimal / (L) Rear Fender, Molding - Scratch - Small / (L) Rear Door, Molding - Scratch - Minimal / (L) Front Door, Molding - Scratch - Small / (L) Mirror - Scratch - Medium / (L) Step, In-panel, Side Spoiler - Scratch - Small</p> |

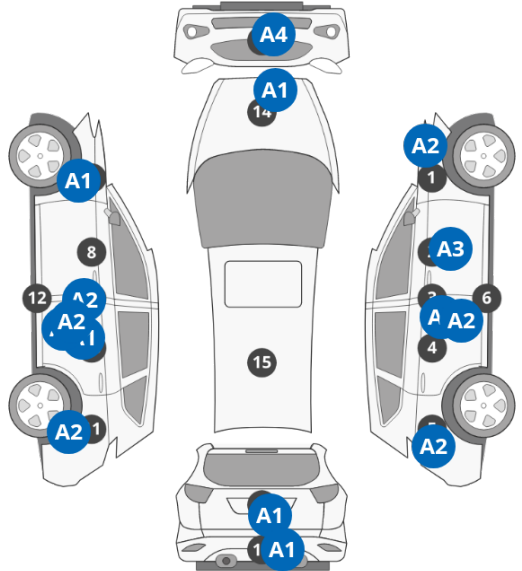
Minimal scratch at left headlight. Incomplete tools. With warranty booklet, seatcover, sparetire, jack, LTO Plate and 2keys.
