## General Information

| Make | Toyota | Model | Hilux Tamaraw |
| Registration No. | GBB3644 | Chassis No. | PAHAD9DAXS1628442 |

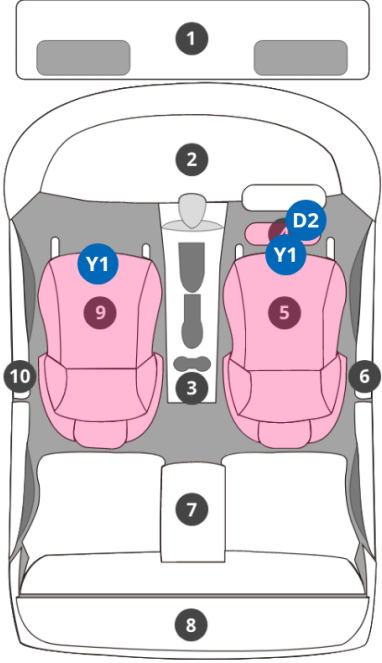
| Interior Evaluation : <b>A</b> | Exterior Evaluation : <b>C</b> |
|---|---|
| <b>Remarks</b><br>(L) Front Seat - Grime - Minimal / (R) Front Seat - Grime - Minimal / (L) Front Floor Mat - Worked - Small | <b>Remarks</b><br>(R) Front Fender, Molding - Scratch - Minimal / (R) Front Door, Molding - Scratch & Dent - Small / (R) Center Panel - Scratch - Minimal / (R) Step, In-panel, Side Spoiler - Scratch - Minimal / (R) Side Gate - Scratch - Small / Rear Bumper, Lamps, Panels - Scratch - Medium / Rear Gate - Scratch - Small / Cargo Bed Floor - Scratch - Large / (L) Side Gate - Scratch - Small / (L) Front Door, Molding - Dent - Small / (L) Step, In-panel, Side Spoiler - Scratch - Small / Front Bumper, Grille, Lamps - Scratch - Small / Bonnet, Headlight - Scratch - Small / Roof - Scratch - Small |
